RICHLAND ENGINEERING LIMITED

May 9, 2019

Re: 2019 Bridge Inspections
Johnson's Island Causeway
Ottawa, Ohio

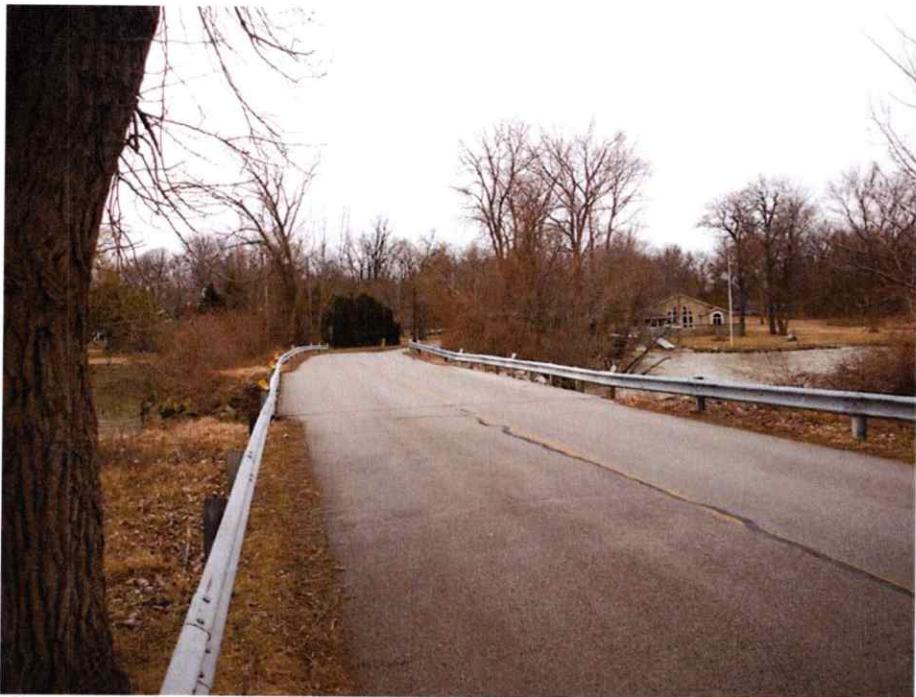
Photo #1 is looking south at Bridge #1. The asphalt is in good condition and there are no reflective cracks from the box beam joints seen in the pavement at this time.

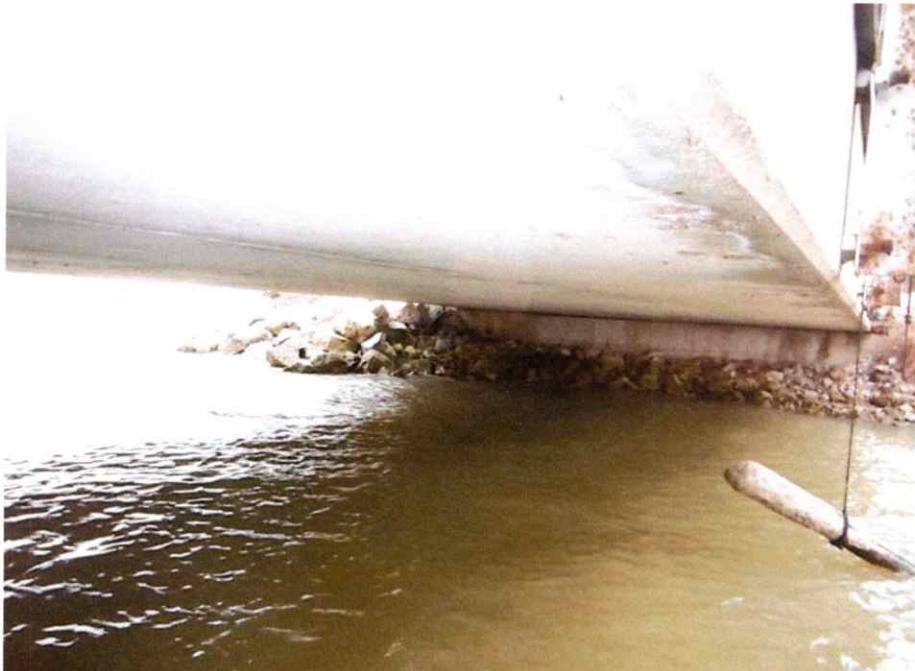
Photo #2 is looking north along the east side of the bridge. Note how dry the beams and abutments are. The waterproofing seems to be working well.

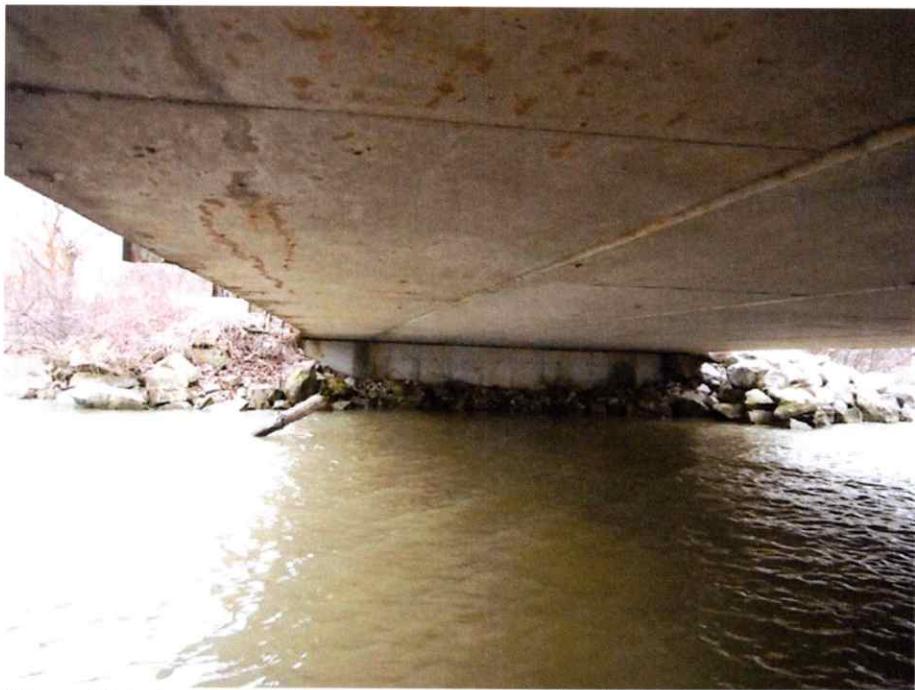
Photo #3 is looking at the south abutment. The dark spots seen on the abutment breast wall just appear to be staining from previous water leakage.

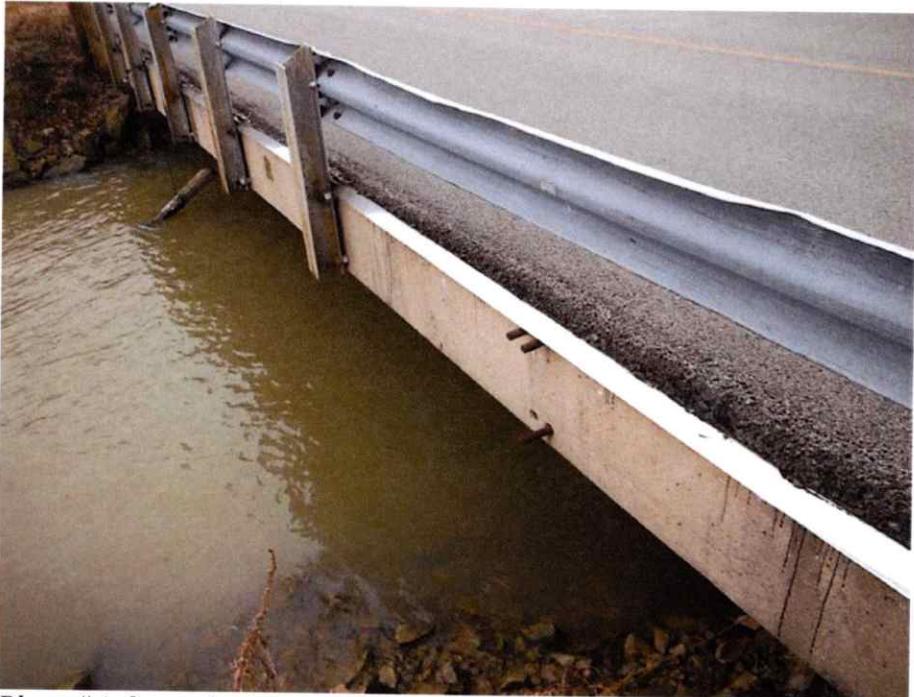
The northern most railing post on the bridge is missing on the east side. The northern most railing post on the west side is missing an anchor nut and another three nuts are loose. The single guardrail rail without a tubular backup does not meet current minimum standards.

Photo #4 shows the missing railing post near the end of the east side that should be replaced.

1. Replace missing railing post and fix anchor bolt problems with other posts.
2. Consider upgrading railing to deep beam railing with tubular backup.
3. Maintain the rock channel protection around and in front of the abutments.

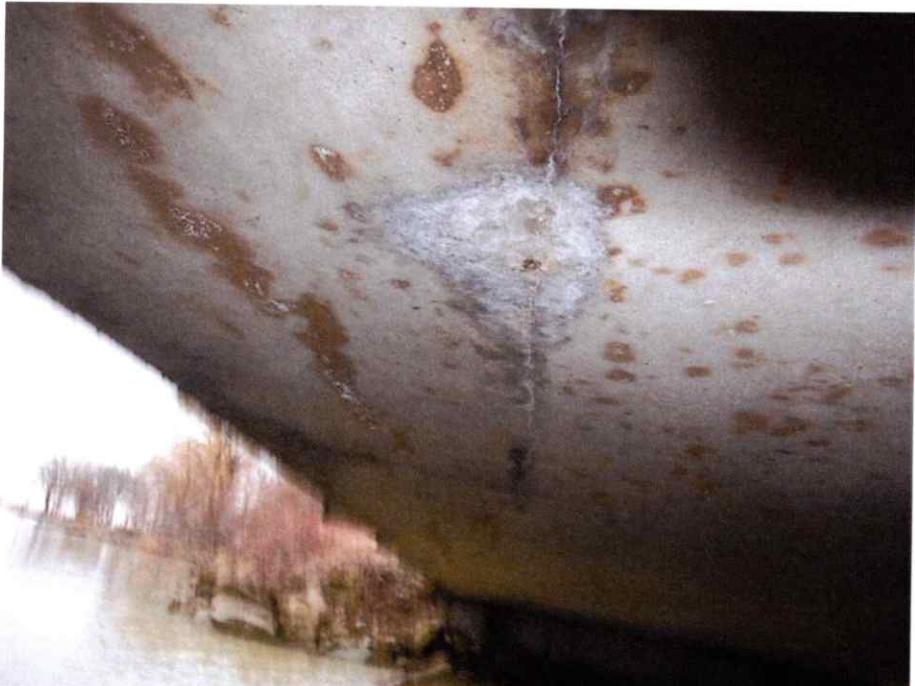
Photo #5 is taken at the north end of the east beam that was damaged and cracked allowing water from the deck to cause additional deterioration. Notice how dry it is now (compare with the wet rusty condition seen on the bottom of the beam in the previous report).

Probably the most serious problem is the cracking, leaking and rusting found on the north end of the east beam (see photo #5). The cracking and beam damage had been previously progressing due to water leaking through the asphalt and down the beam joints. Hopefully, the waterproofing sealing of the top and end of the beam will greatly limit additional deterioration. The life of this beam is hard to quantify, but 10 to 15 years seems to be a safe estimate.

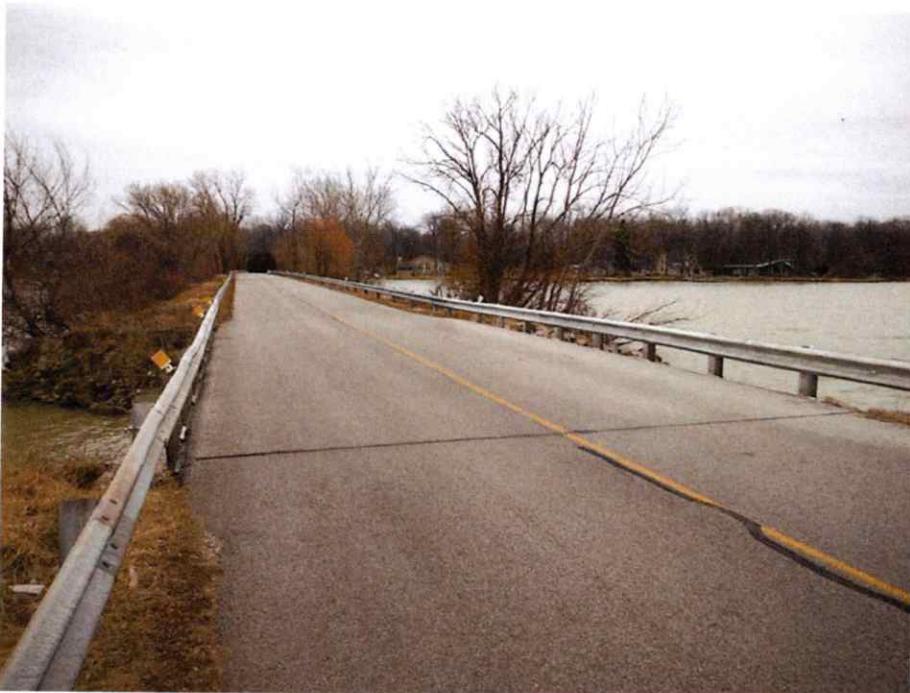
Photo #6 is looking south at Bridge #2. The asphalt is in good condition and there are no reflective cracks from the box beam joints seen in the pavement at this time.

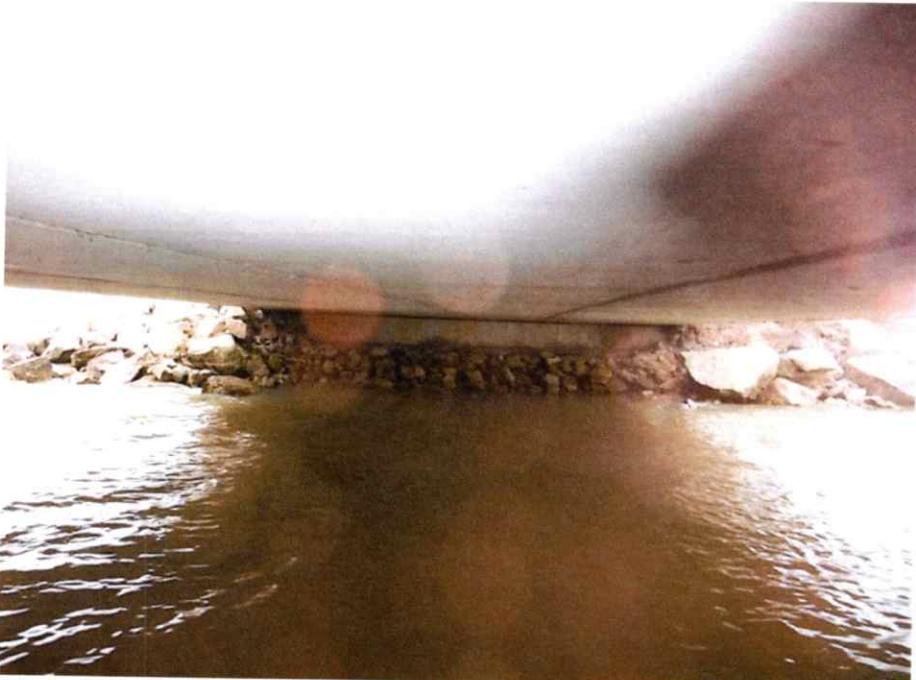
Photo #7 is looking at the north abutment. The dark spots seen on the abutment breast wall just appear to be staining from previous water leakage.

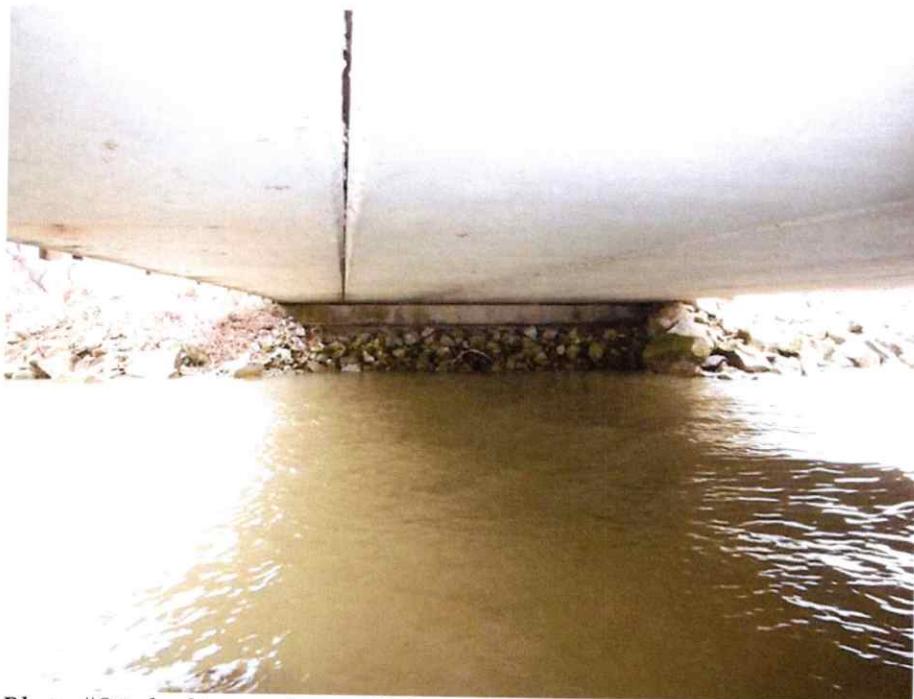
Photo #8 is looking at the south abutment. Note how dry the beams and abutments are. The waterproofing seems to be working well.

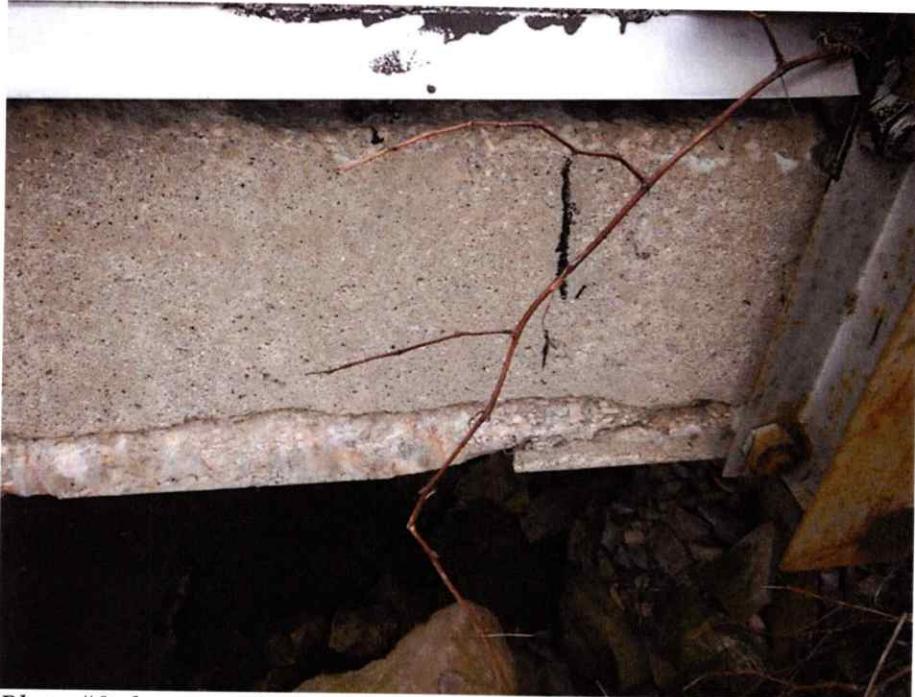
The north railing post on the east side has apparently been hit, cracking the side of the box beam and compromising the anchorage. This railing does not meet minimum standards.

Photo #9 shows cracking and deterioration of the north end of the bottom of the east beam. This damage apparently resulted from an impact to the railing.

The box beams are in fair condition with a major problem in the east beam with large cracks and delaminated concrete due to the railing post anchorage breaking from collision damage. The life of the beam is now much reduced since the steel reinforcing and prestressing strands have been exposed to water and deicing chemicals (see photos #9 & 10) and there are locations of water staining through the beam joints visible on the bottom. However, the waterproofing seems to have eliminated this water leakage now. The life of this beam is hard to quantify, but 10 years seems to be a safe estimate.

1. It is probably too late to repair or improve the damaged east beam and replacement will be eventually required. However, the water drainage through the beam has been greatly reduced with the installation of the waterproofing and this could greatly extend the beam's life.
2. Consider upgrading railing to deep beam railing with tubular backup. At a minimum tighten or add nuts on the posts as required.
4. Maintain the rock channel protection around and in front of the abutments.

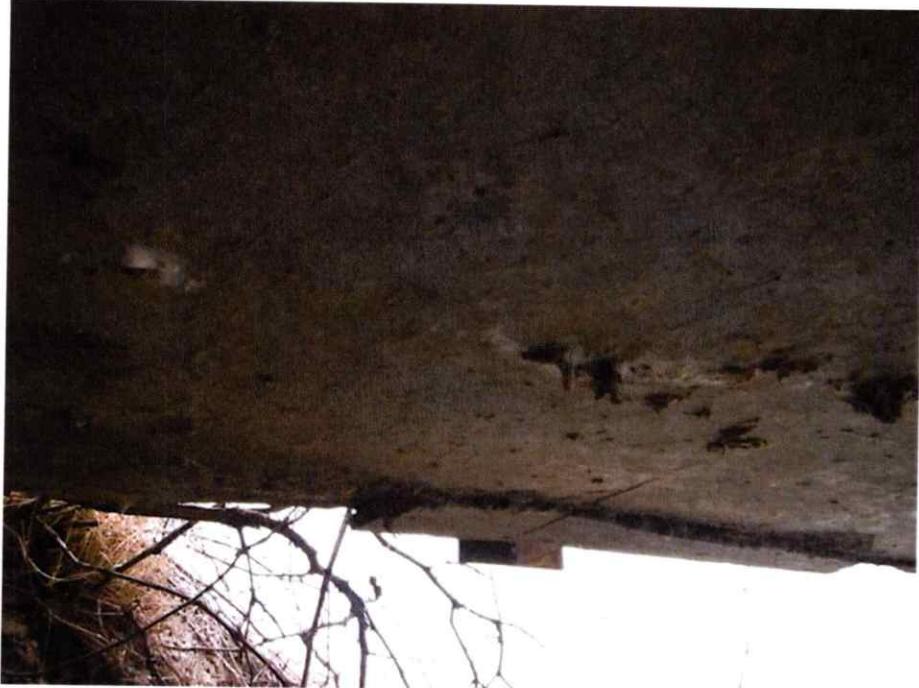
Photo #10 shows the same east beam damaged area looking at it from under the bridge. The beam bottom is now dry after the installation of the waterproofing.

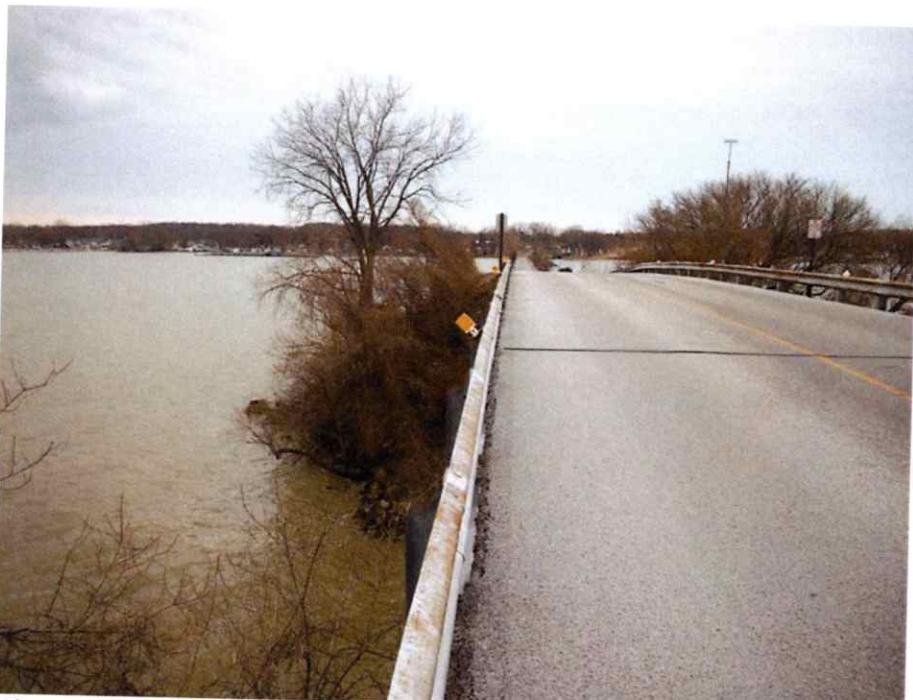
Photo #11 is looking north at Bridge #3. The asphalt is in good condition and there are no reflective cracks from the box beam joints seen in the pavement at this time.

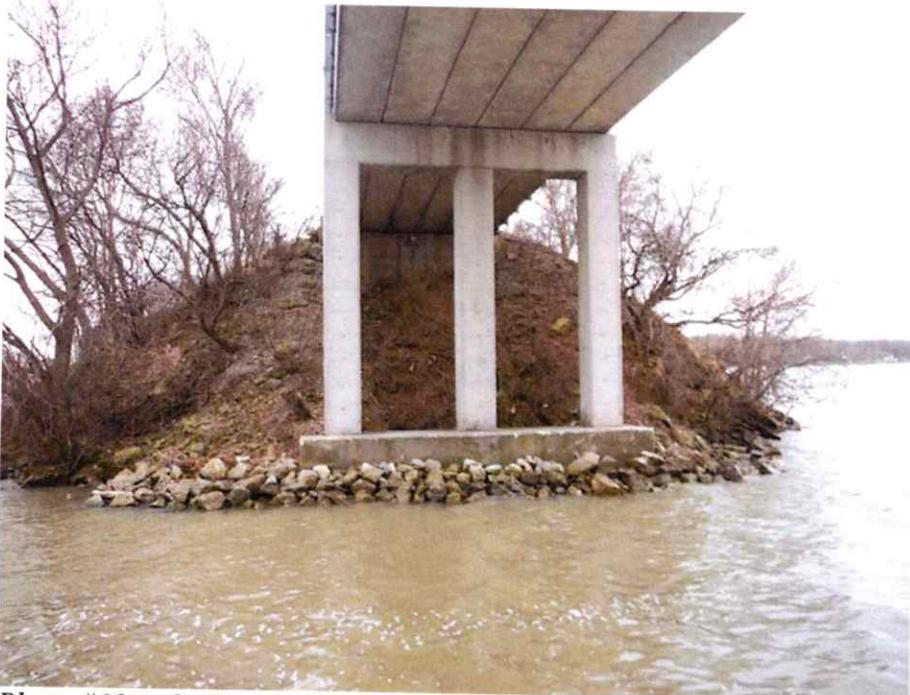
Photo #12 is looking at the south pier and abutment. Note the steepness of the embankment slope. The rock channel protection is in good condition. The vines and brush have been sprayed.

The abutments are in satisfactory condition. The water previously leaking from the superstructure has stained the face of the abutments (see Photo #12), but the concrete surfaces all seem to be dry now. The spill-through slopes, in front of the abutments, are rutted, muddy with some rock protection. Most of the vines and briars appear have been sprayed and are dead now.

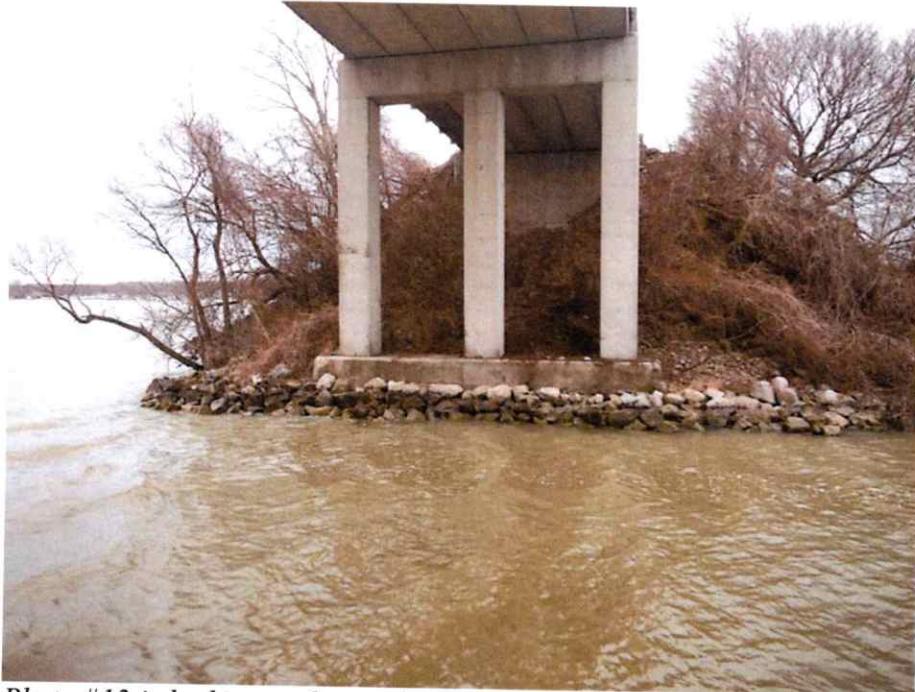
Photo #13 is looking at the north pier and abutment. The steep embankment is very uneven and eroded. The rock channel protection is also in good condition here. The bottoms of the beams in all spans appear to be dry.

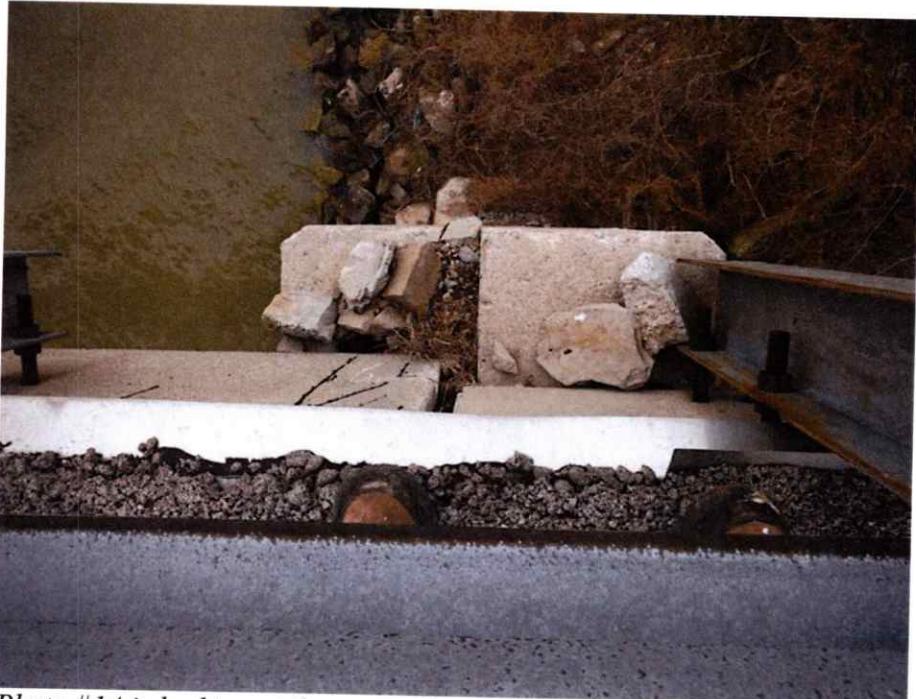
The box beams are in satisfactory condition. The end span beams are a smaller size than the center span beams and a special two level pier seat is required to raise the seat up for the end spans. In this case the infill continuity concrete was poured between the center span beams and end span high seat limiting expansion movement of the center span. Cracking and spalling of the continuity concrete and asphalt wearing surface cracks are the likely consequence. Some patching of this concrete at the side of the deck appears to have been done (see Photo #14).

Photo #14 is looking at the west side of the north pier joint. Note that there is no concrete in the joint here between the beams. The other locations still have the concrete in the joint or have been patched.

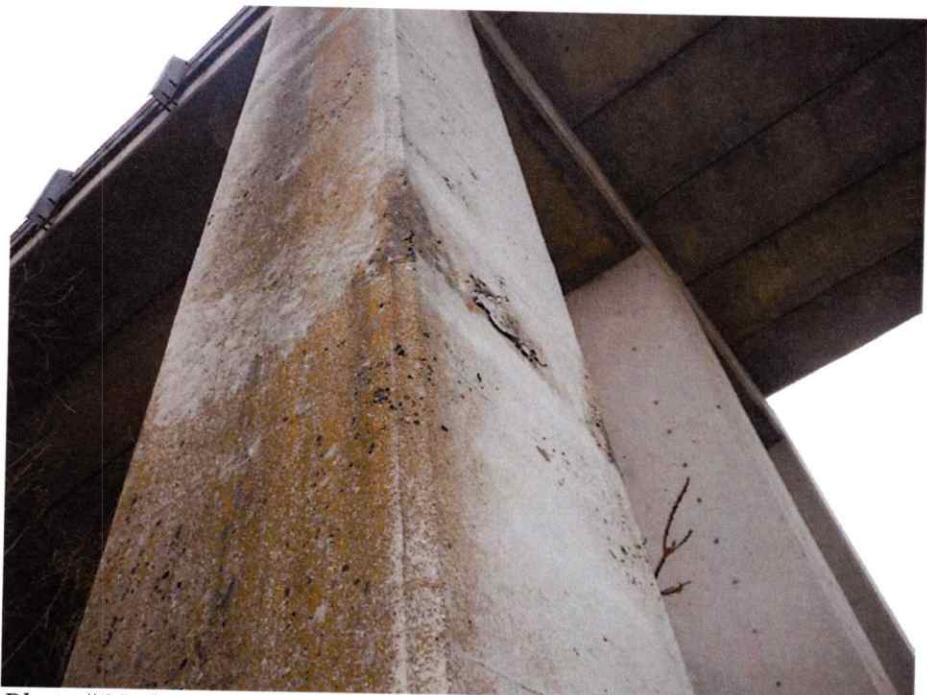
Photo #15 shows the honeycombed and spalling concrete at the north pier. There does not seem to be much change from previous inspections.

The pier legs, especially the north pier, were constructed with a lot of honey comb areas. There are several cracks and one spall area on the west leg of the north pier. There is water staining on the pier cap from the superstructure, but cap and leg areas seem to be dry now. There does not seem to be much change or addition deterioration when compared with previous inspections.

1. Consider upgrading railing to deep beam railing with tubular backup.
2. Patch spall and honey comb areas on piers legs. Epoxy-Urethane sealing could also be done after repairing the pier legs.
3. Continue to use an asphalt sealer at the pavement joints over the piers and at the abutments.
4. Monitor the settlement behind the north abutment and then patch the pavement when the bump up to the bridge becomes significant. Observe the embankment and any erosion or movement on the slopes possibly causing change that is effecting the settlement of the pavement above.

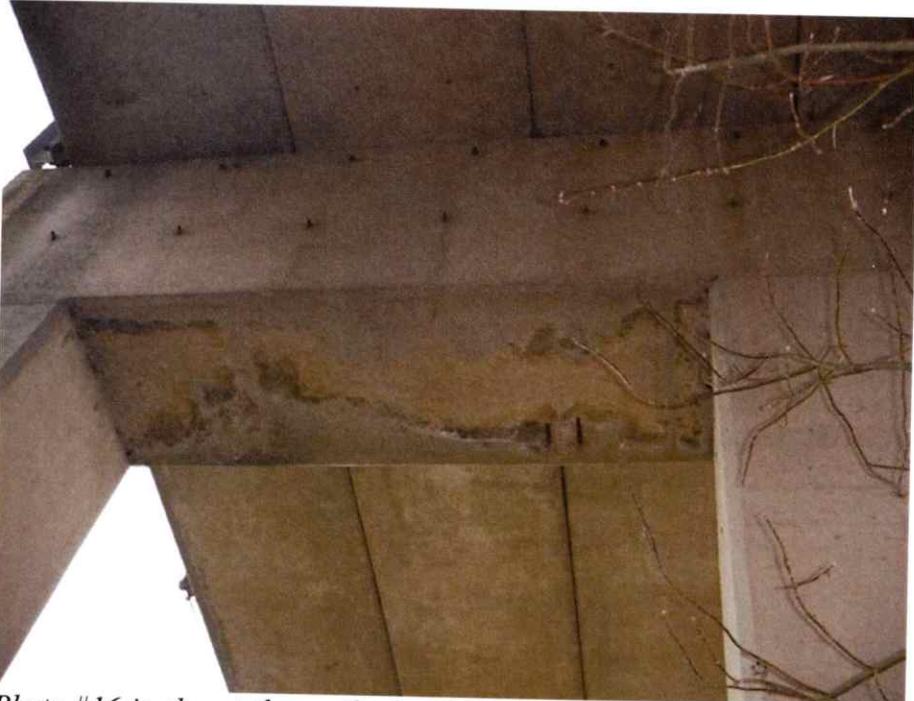
Photo #16 is also at the north pier. The lack of concrete cover on the bottom of the pier cap is the cause of the exposed bars here.

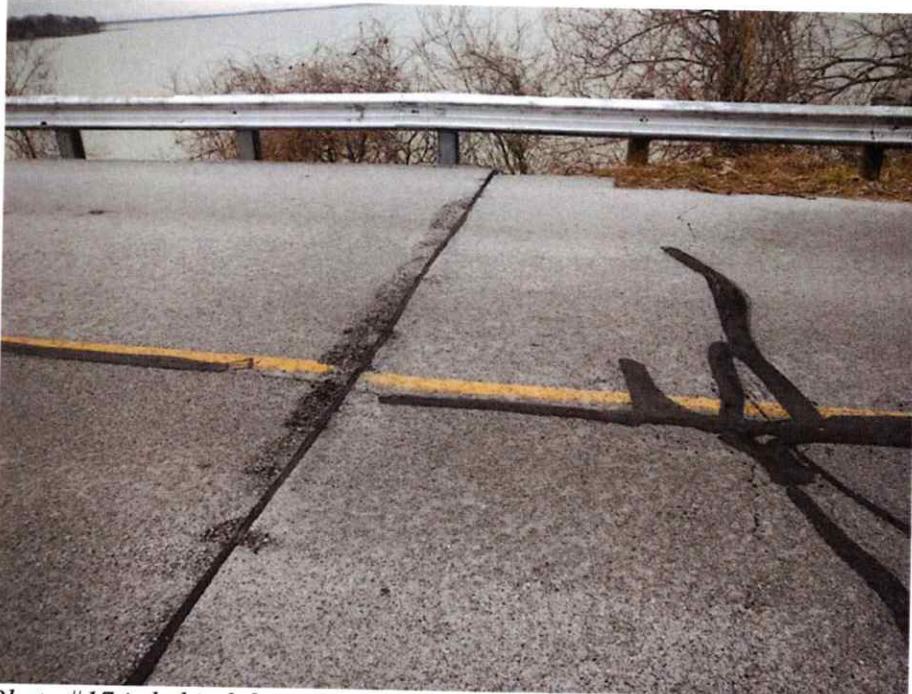
Photo #17 is behind the north abutment and shows the embankment settlement.

The pavement has settled behind the north abutment and has created a bump for south bound traffic coming on to the bridge. This area was dug out so the waterproofing and drain system could be installed. It seems that the steep embankment may be bulging out and settling over time. This problem has been noticed over several inspections and appears to be an ongoing, long term problem.

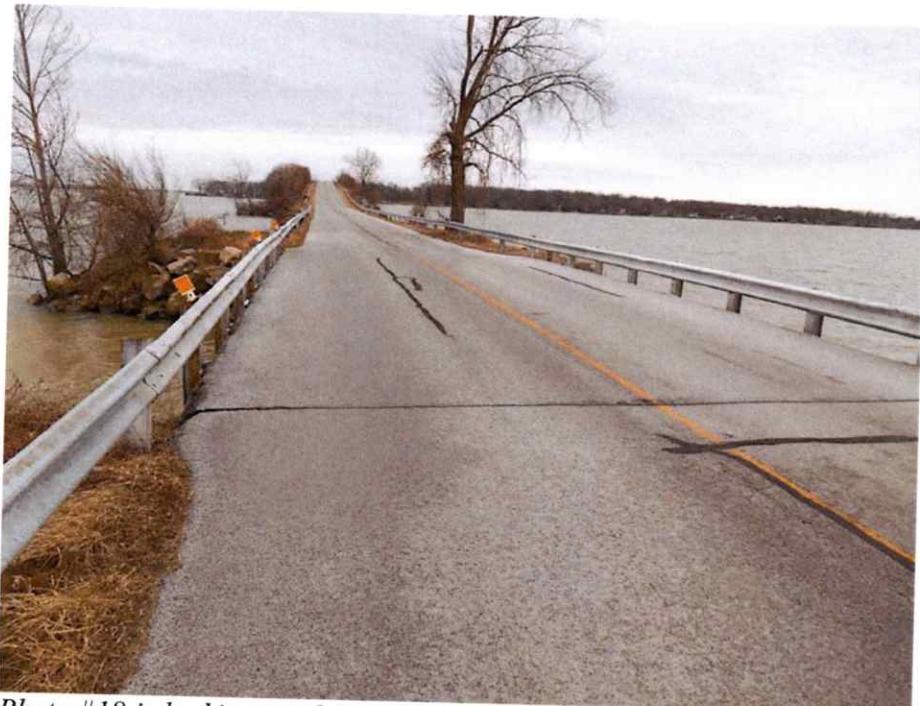
Photo #18 is looking south at Bridge #4. The longitudinal sealer seen on the deck is apparently over one of the beam joints.

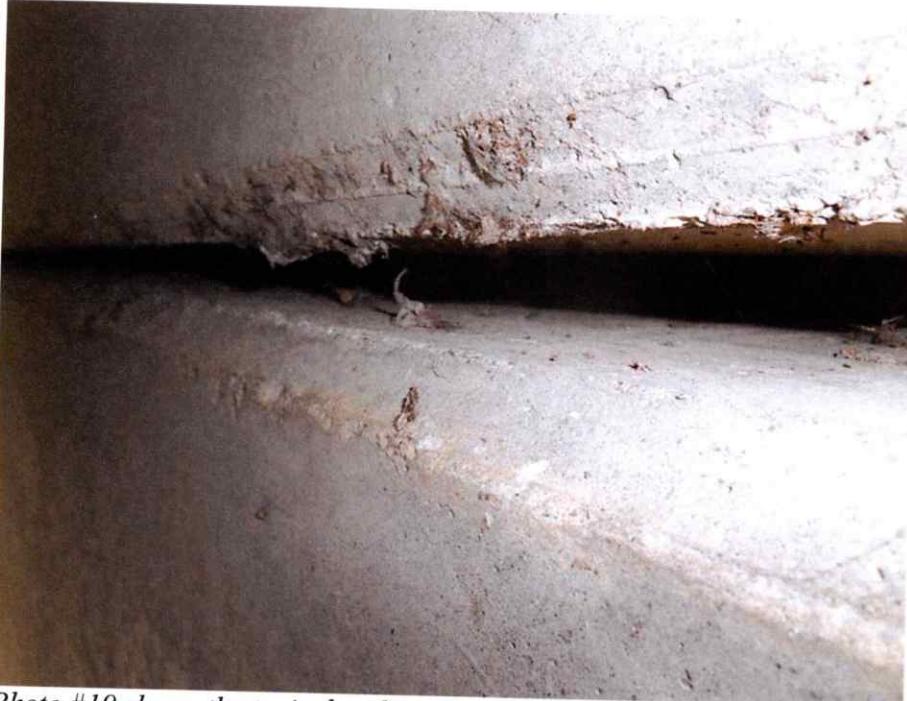
The key joints between the box beams were repaired sometime after our 1999 inspection. We noticed some joint cracking during our 2007 inspection. During this inspection, differential beam movement was not apparent even though large vehicles were crossing the bridge, but there were some reflective cracks from the box beam joints that had been sealed (or partly sealed). The beam joints on this bridge seem to be wider than normal and have always been a problem that is causing asphalt cracking (see photo #19). The waterproofing membrane should be flexible enough to allow some movement between beams and still prevent leakage between the beams.

Photo #19 shows the typical wider than desirable box beam joints,

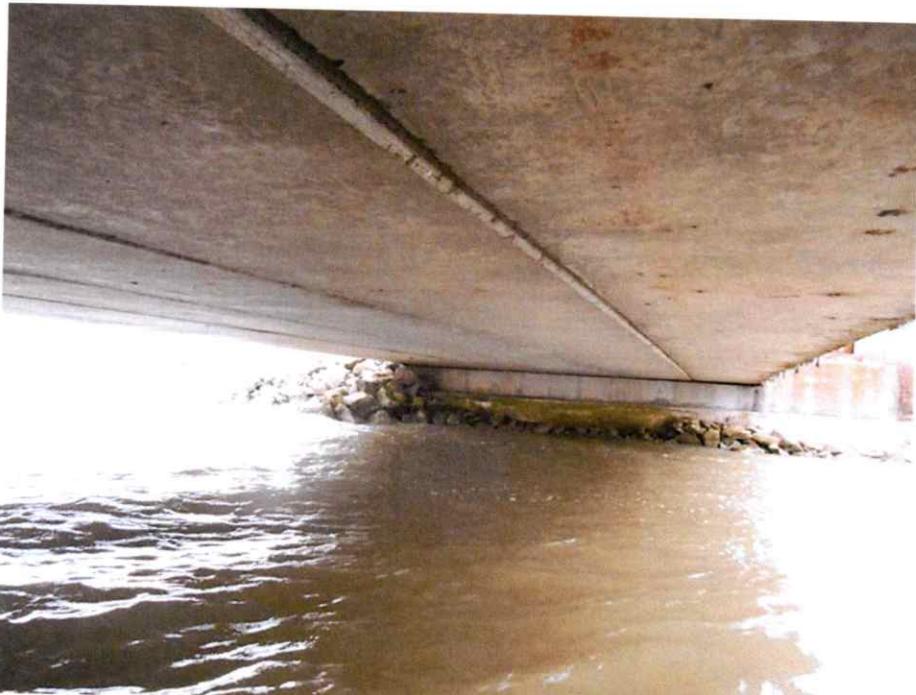
Photo #20 is looking at the north abutment. Adding additional rock channel protection would be desirable.

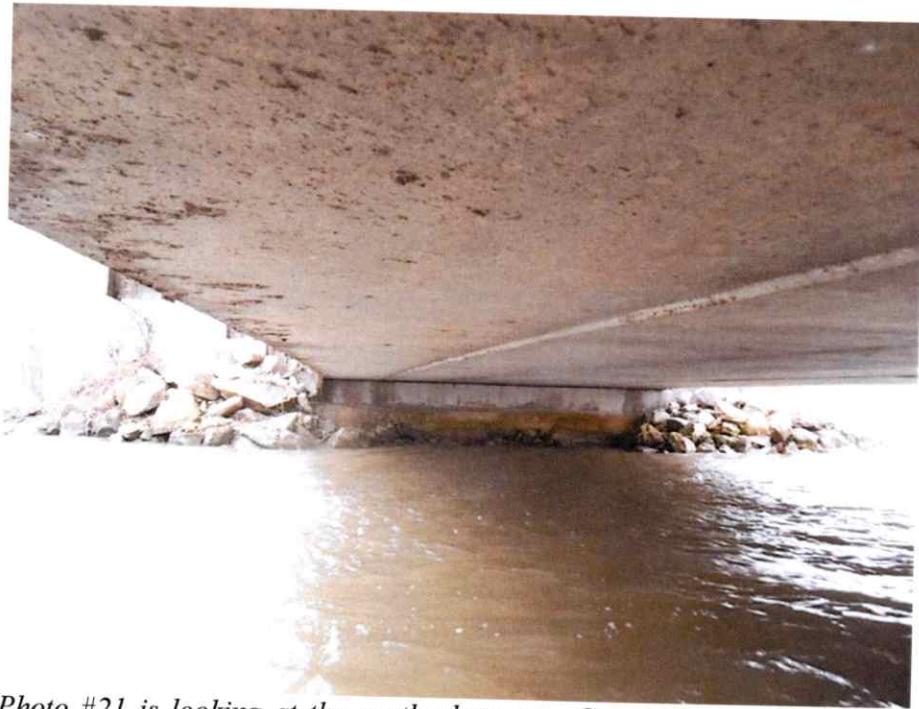
The abutments are in satisfactory condition after being repaired since being severely eroded at the water level on the front faces. There is now rock channel protection around and in front of the abutments protecting them from wave action. The south abutment rock has moved down or washed away and more is required (see photo #21).

Photo #21 is looking at the south abutment. Some of the rock channel protection appears to have slumped down in front of the abutment breast wall.

1. Consider upgrading railing to deep beam railing with tubular backup. At a minimum tighten the nuts on the posts as required.
2. Maintain the rock channel protection around and in front of the abutments (especially at the south abutment).
3. Continue to seal any reflective pavement cracking over the bridge.

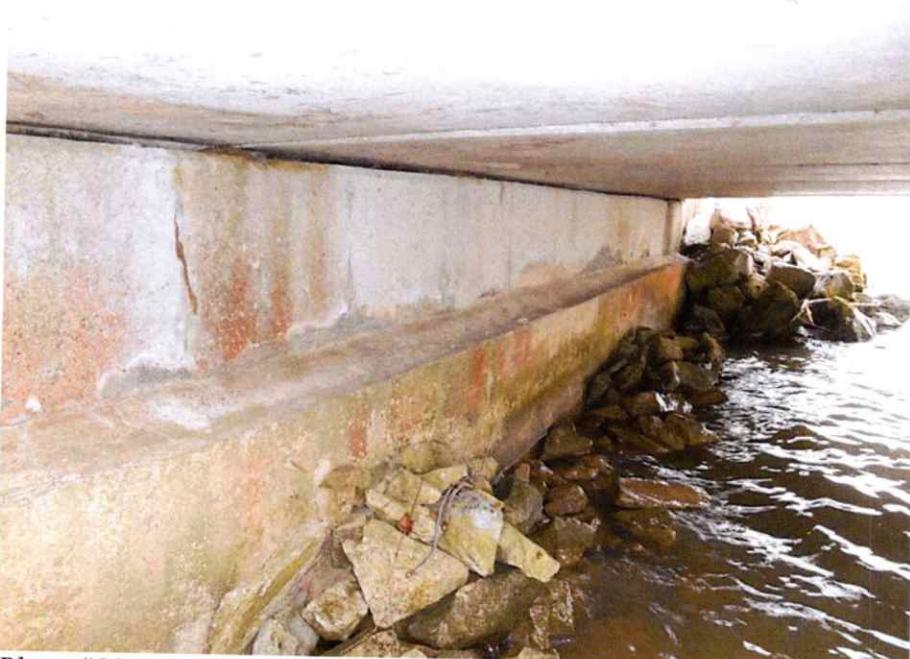
Photo #22 is looking west along the south abutment. The repair work is visible and it is still in good condition.

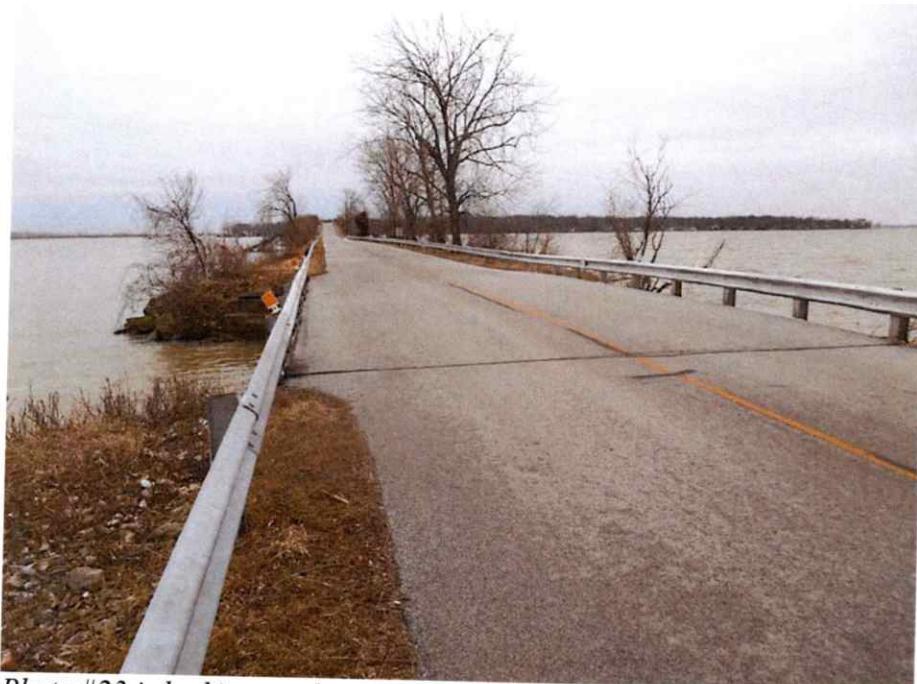
Photo #23 is looking south at Bridge #5.

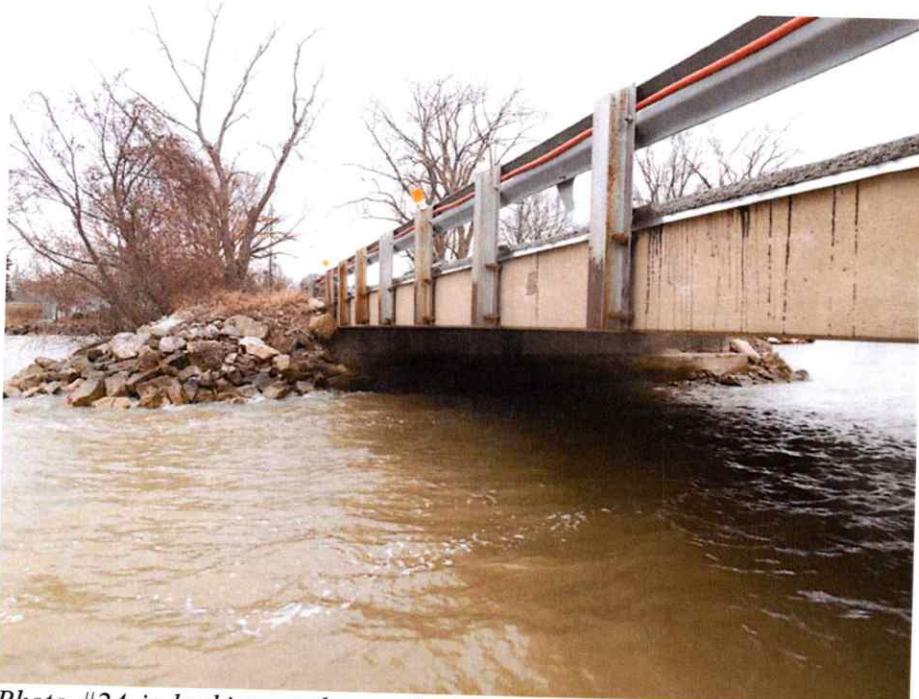
The abutments were repaired on this bridge also and are now in satisfactory condition. Rock channel protection was added around and in front of the abutments to protect against wave action, but is now largely missing in front of both the north and south abutments (see photos #24-#26).

Photo #24 is looking at the north abutment. Note that additional rock channel protection is needed.

1. Consider upgrading railing and deep beam railing with tubular backup.
2. Maintain the rock channel protection around and in front of the abutments (especially at the south abutment).

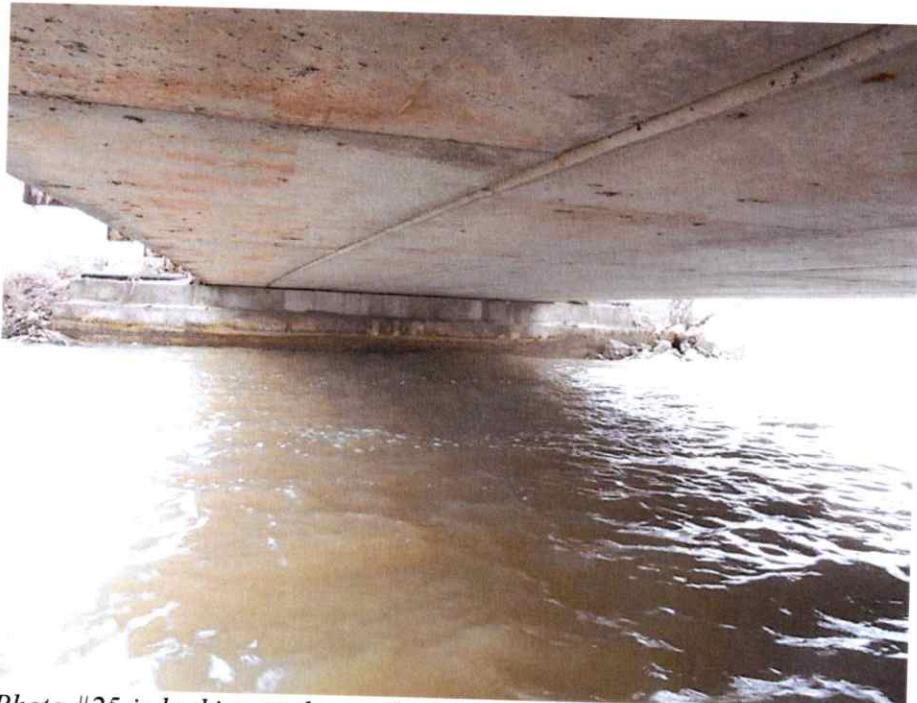
Photo #25 is looking at the south abutment. Little rock channel protection is still visible above the water. Note that the bottom of the beams and the face of the abutment are dry now with the new waterproofing.

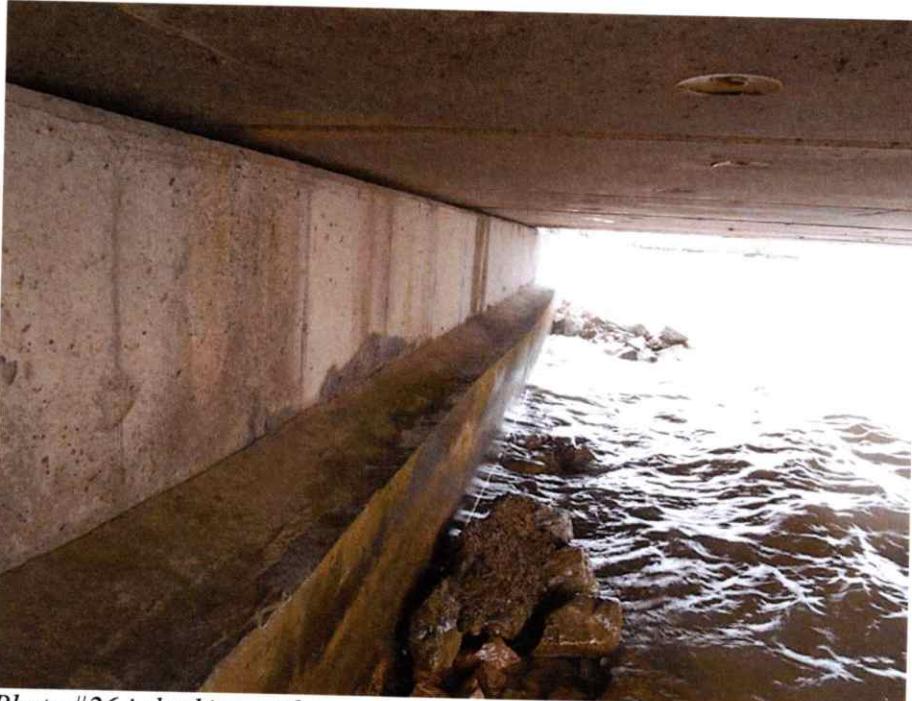
Photo #26 is looking at the north abutment concrete repairs which appear in good condition.
