Re: 2024 Bridge Inspections
Johnson's Island Causeway
Ottawa, Ohio

On May 13, 2024, Richland Engineering Limited inspected the five bridge structures on the Johnson's Island Causeway Bridge. All five structures have precast prestressed box beam superstructures with asphalt wearing surfaces and reinforced concrete substructures.

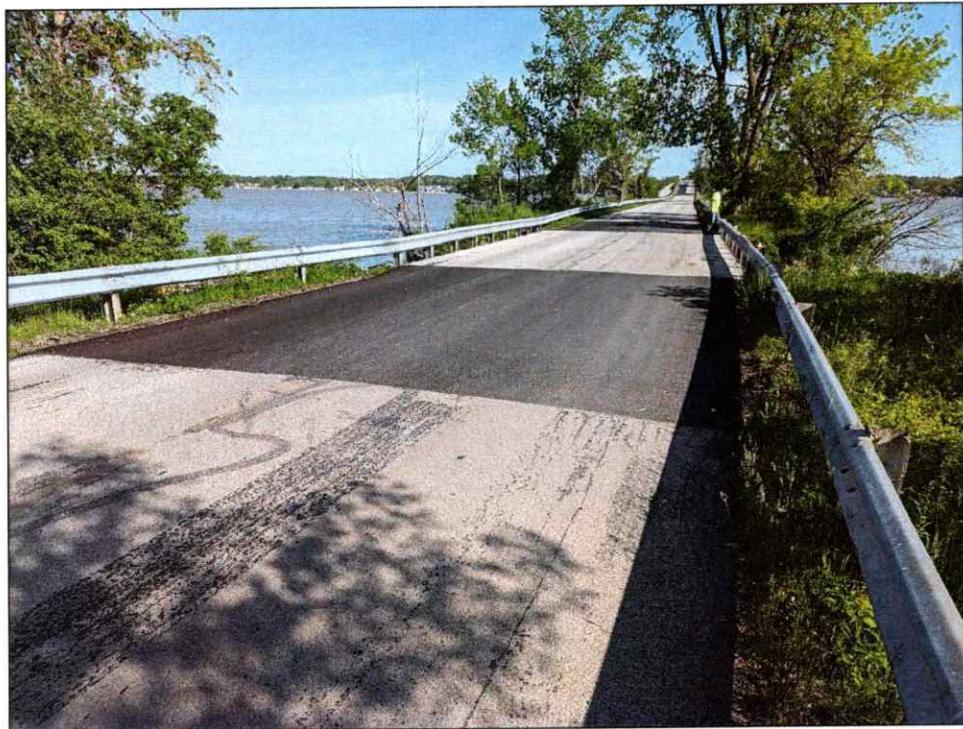
Picture 1: Looking north (Bridge 1).

The new approach pavement corrects settlement and smooths the road surface.

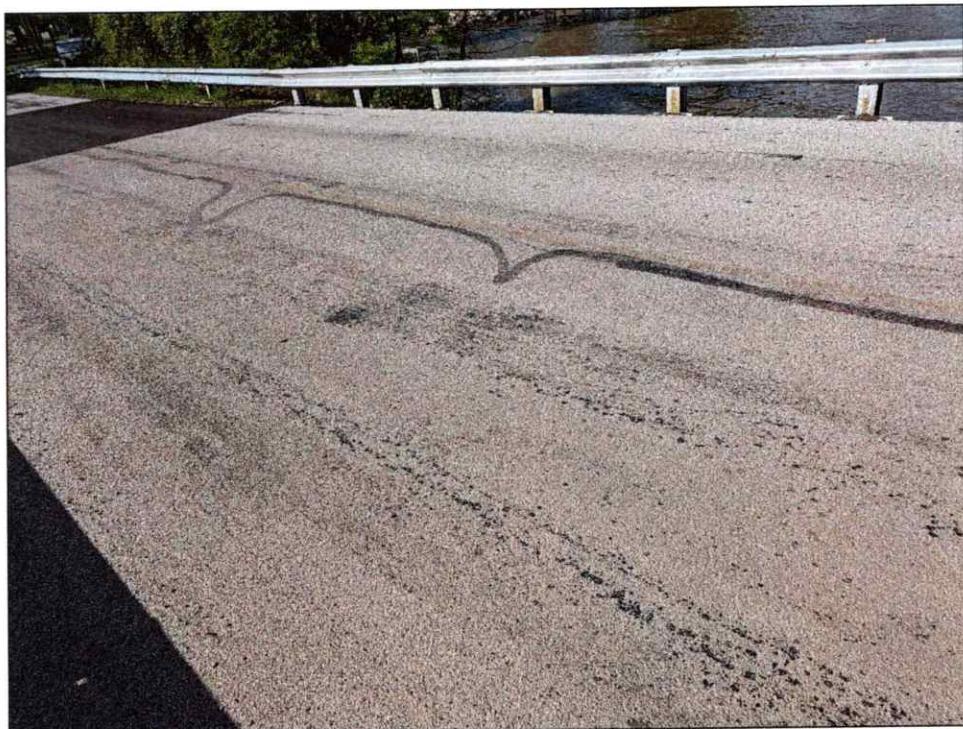
The asphalt wearing surface on the box beams is in good condition. The asphalt pavement behind the abutments was removed to place porous backfill and drainage pipes to drain the fill and correct the settlement. The drip strip works with the beams' waterproofing on both sides of the bridge to keep water from draining down the beam sides. The upturned sections of the drip strip keep water from running directly off the road surface onto the railing posts. These sections are generally covered with asphalt, which allows the water to flow onto the railing posts. The asphalt and waterproofing still seems to be preventing water from draining down to the beams.

Picture 2: Wearing surface (Bridge 1).

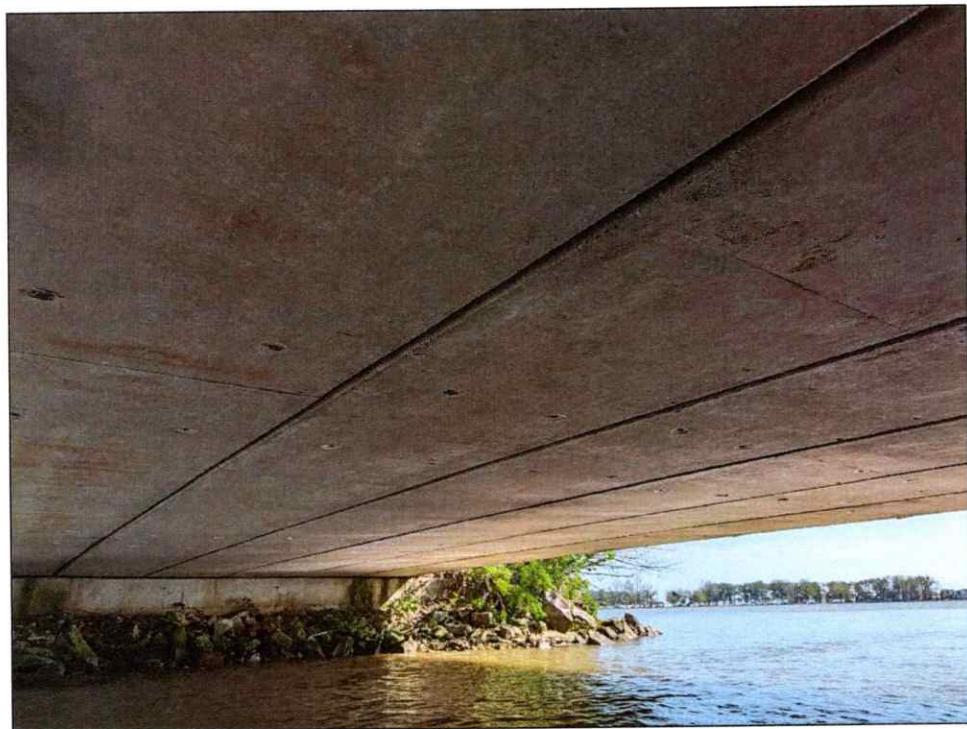
The box beams are in satisfactory condition with some problem locations. There are spall locations at the southwest bearing and the west beam joint is wide at the bottom. There are many locations of water staining from previous leaking through the beam joints visible on the bottom. However, as mentioned above, the waterproofing seems to have stopped the water leakage through the deck.

Picture 3: General picture of the beams (Bridge 1).

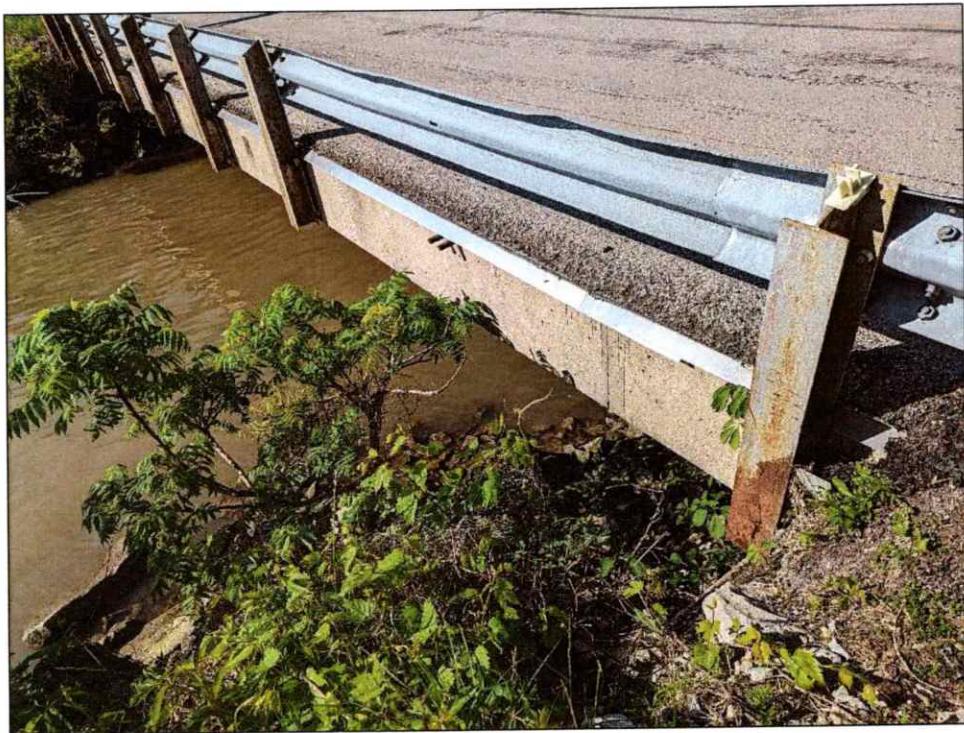
The northernmost railing post on the east side of the bridge is missing. The northernmost railing post on the west side is missing an anchor nut. Another three posts on the bridge have loose nuts. The single guardrail rail without a tubular backup does not meet current minimum standards.

Picture 4: Missing railing post at northeast (Bridge 1).

- Replace missing railing post and fix anchor bolt problems with other posts.
- Consider upgrading railing to deep beam railing with tubular backup.
- Maintain the rock channel protection around and in front of the abutments.
- Remove vegetation from the rock channel protection at the abutments.
- Remove asphalt covering the drip strip at the railing posts.

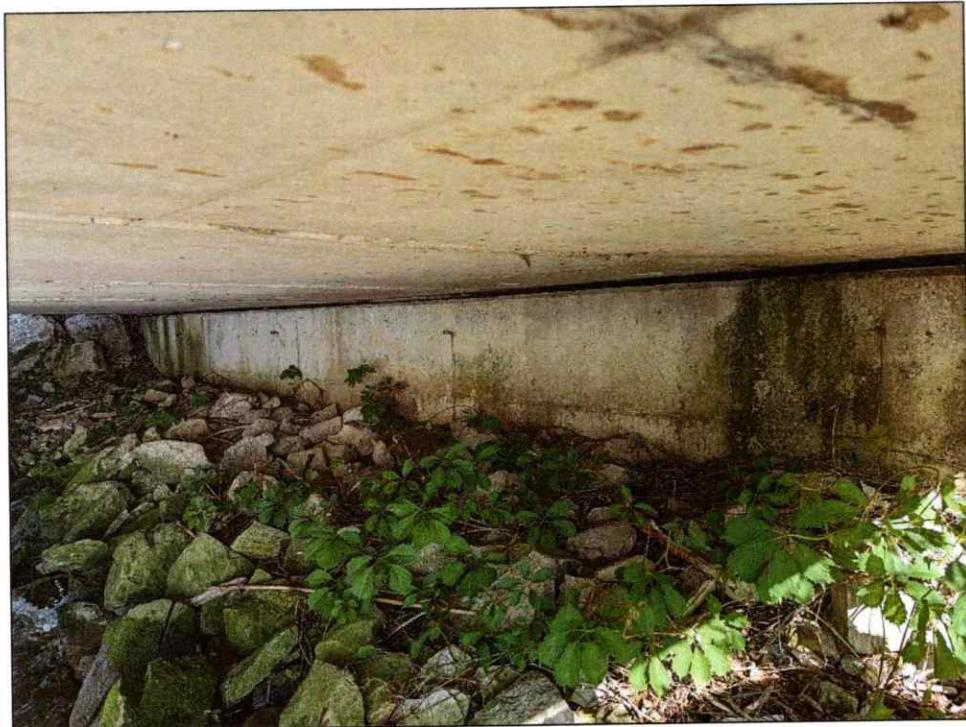
Picture 5: North abutment (Bridge 1).

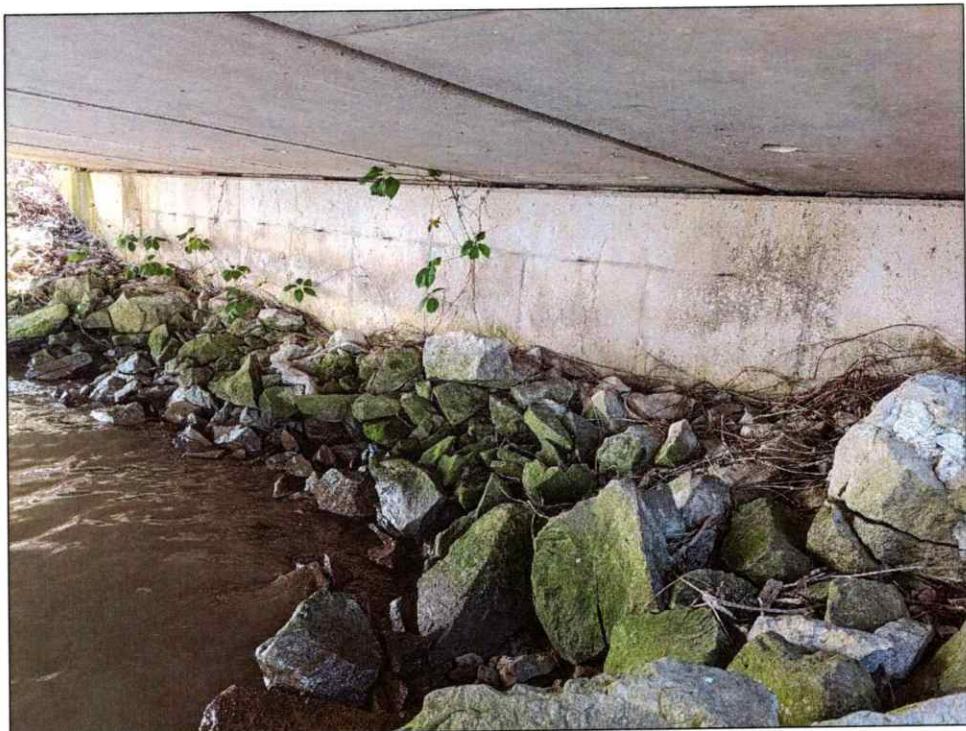
Picture 6: South abutment (Bridge 1).

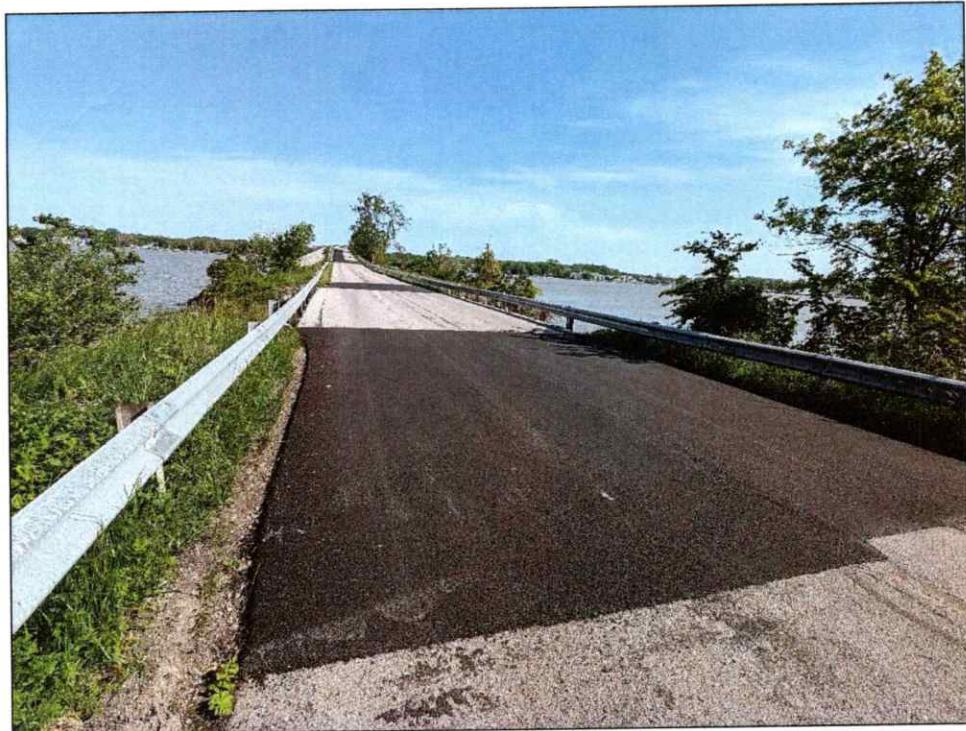
Picture 7: Looking north (Bridge 2).

The new approach pavement corrects settlement and smooths the road surface.

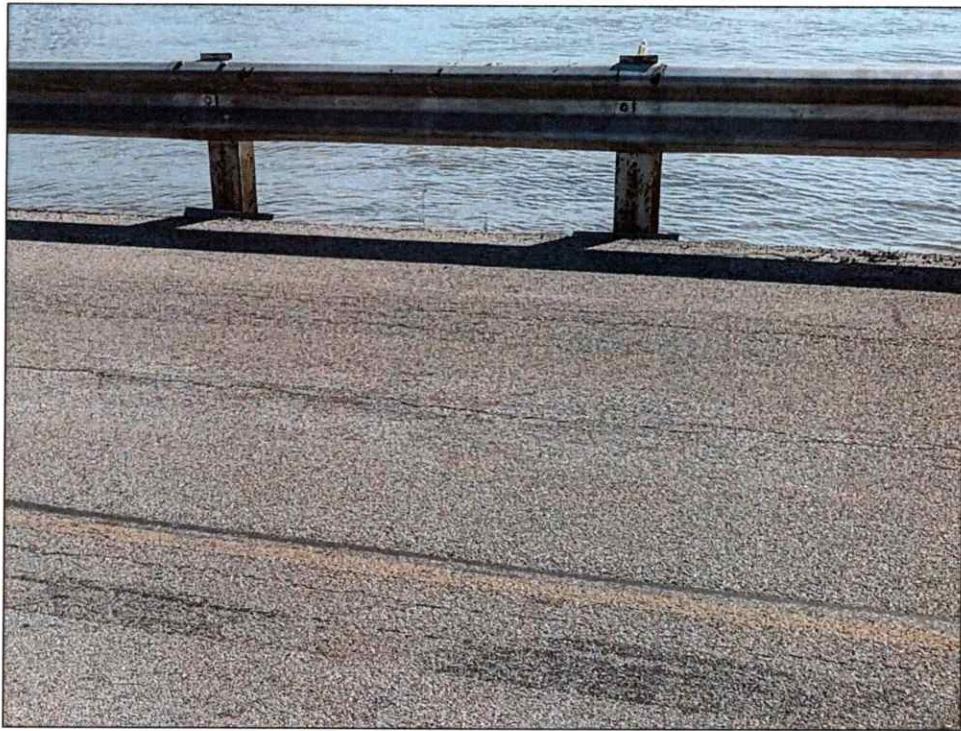
The key joints between the box beams were also repaired at the same time as Bridge 1. During this inspection, there were pavement reflective cracks (see Picture 8) from the box beam joints over the eastern half of the bridge, which usually indicate differential movement at beam joints.

Picture 8: Cracks in the wearing surface (Bridge 2).

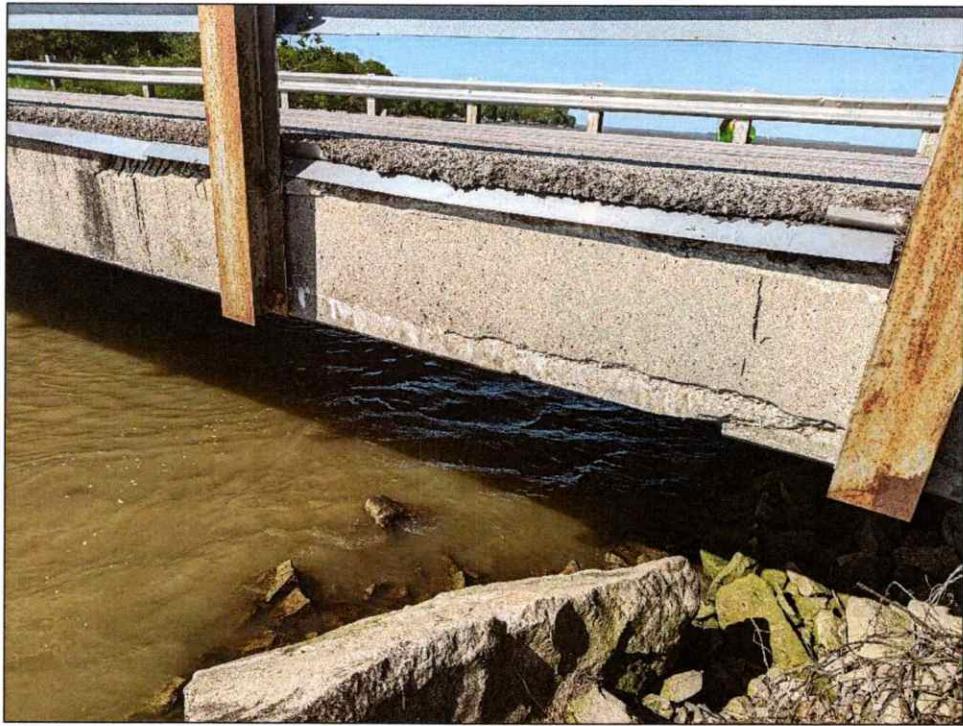
The north railing post on the east side has apparently been hit, cracking the side of the box beam and compromising the anchorage. This railing does not meet minimum standards.

The box beams are in fair condition with a major problem in the east beam with large cracks and delaminated concrete due to the railing post anchorage breaking from collision damage. The life of the beam is now much reduced since the steel reinforcing and prestressing strands have been exposed to water and deicing chemicals (see Picture 9) and there are locations of water staining through the beam joints visible on the bottom. However, the waterproofing seems to have eliminated this water leakage now. The life of this beam is hard to quantify, but 10 years seems to be a safe estimate.

Picture 9: Damage on edge of east beam at north end (Bridge 2).

- It is probably too late to repair or improve the damaged east beam and replacement will eventually be required. However, the water drainage through the beam has been greatly reduced with the installation of the waterproofing and this could greatly extend the beam's life. Patching the outside edge of the beam and then sealing it may also help to slow the deterioration of beam strands. Do not patch the bottom, because if water is entering the beam from another place, the patch will not let water escape and the strands will deteriorate faster.
- Consider upgrading railing to deep beam railing with tubular backup. At a minimum tighten or add nuts on the posts as required.
- Maintain the rock channel protection around and in front of the abutments.
- Seal the cracks in the asphalt wearing surface.
- Remove asphalt covering the drip strip at the railing posts.

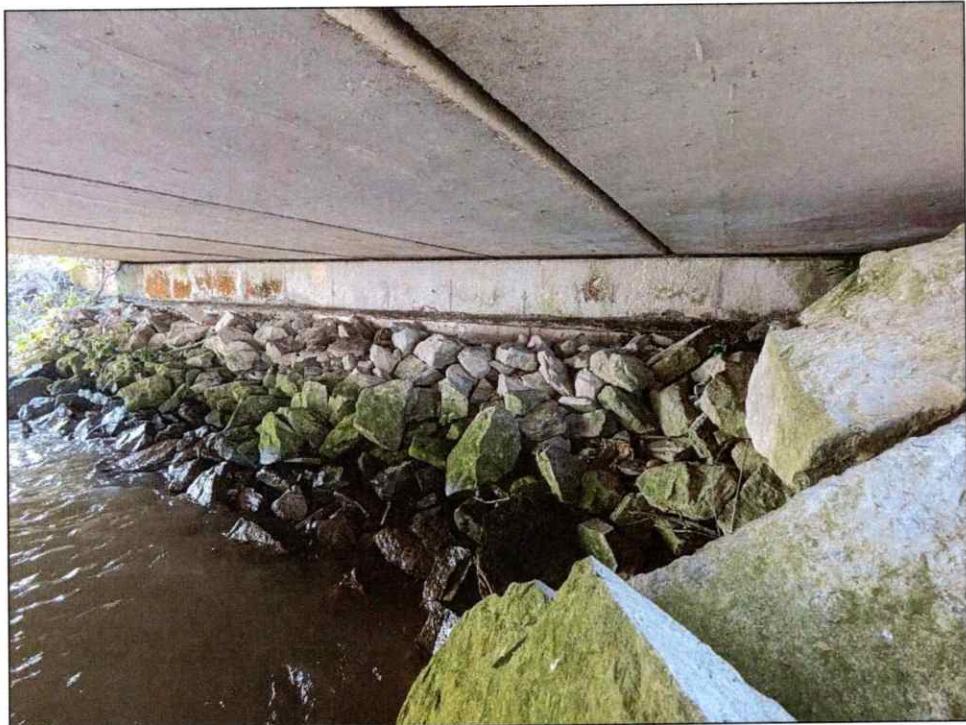
Picture 10: South abutment (Bridge 2).

The abutments are in good condition after being repaired since being severely eroded at the water level on the front faces. The repairs still look in good condition, and there is now rock channel protection around and in front of the abutments protecting them from wave action. The rock channel protection is in good condition.

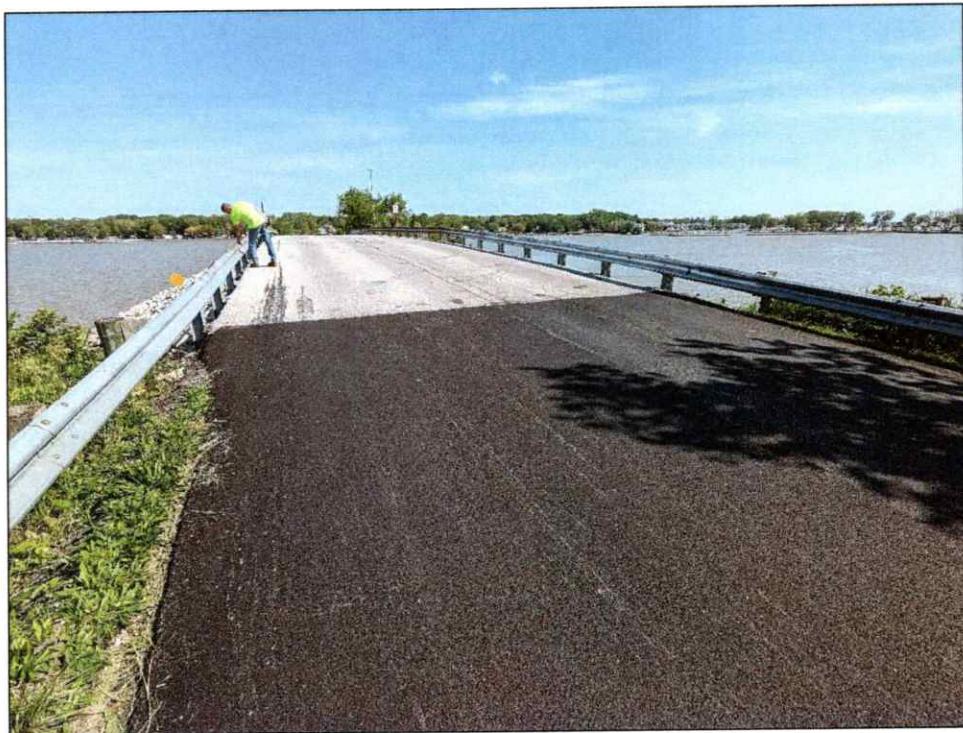
Picture 11: Looking north (Bridge 3).
The new approach pavement corrects settlement and smooths the road surface.

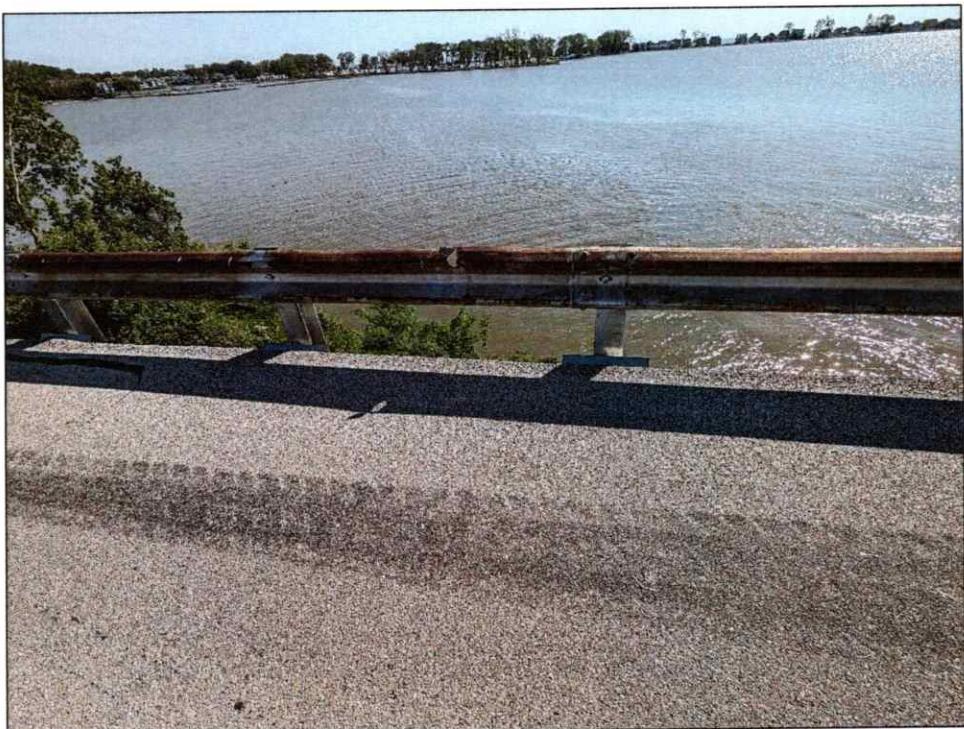
There is a small hole in the east railing in the north span. The railing does not meet minimum standards.

Picture 12: Small hole in east railing (Bridge 3).

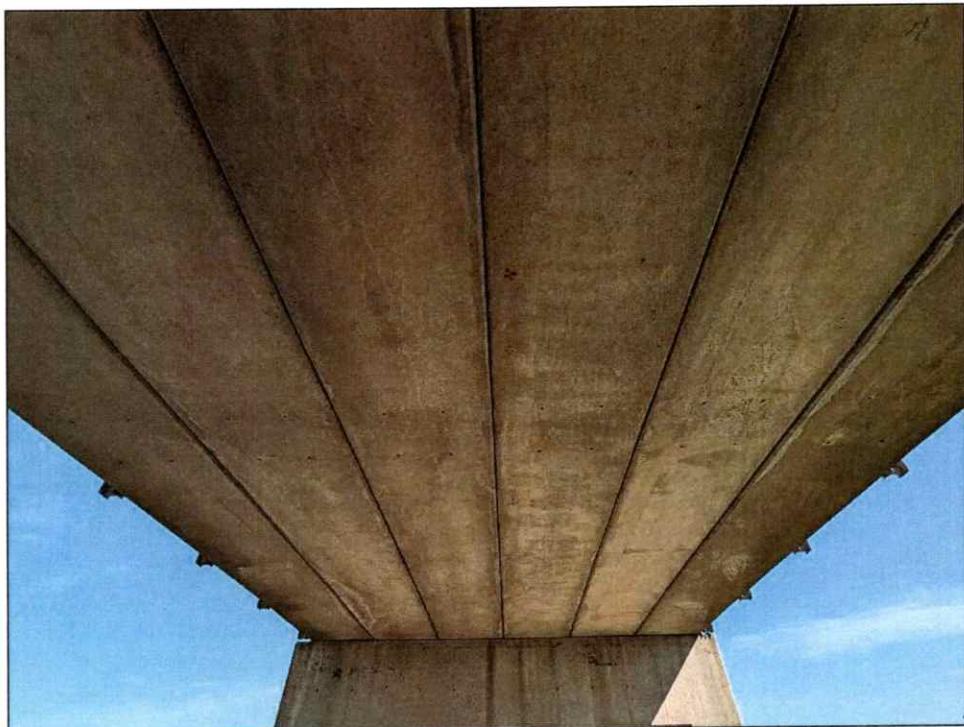
There are many locations of staining from previous water leaking through the beam joints visible on the bottom of the concrete. This is especially true at the piers and abutments where water was previously running down the pier caps and the faces of the abutments from the various leaks above. All these areas appear dry now after the installation of the waterproofing.

Picture 13: Typical underside of beams (Bridge 3).

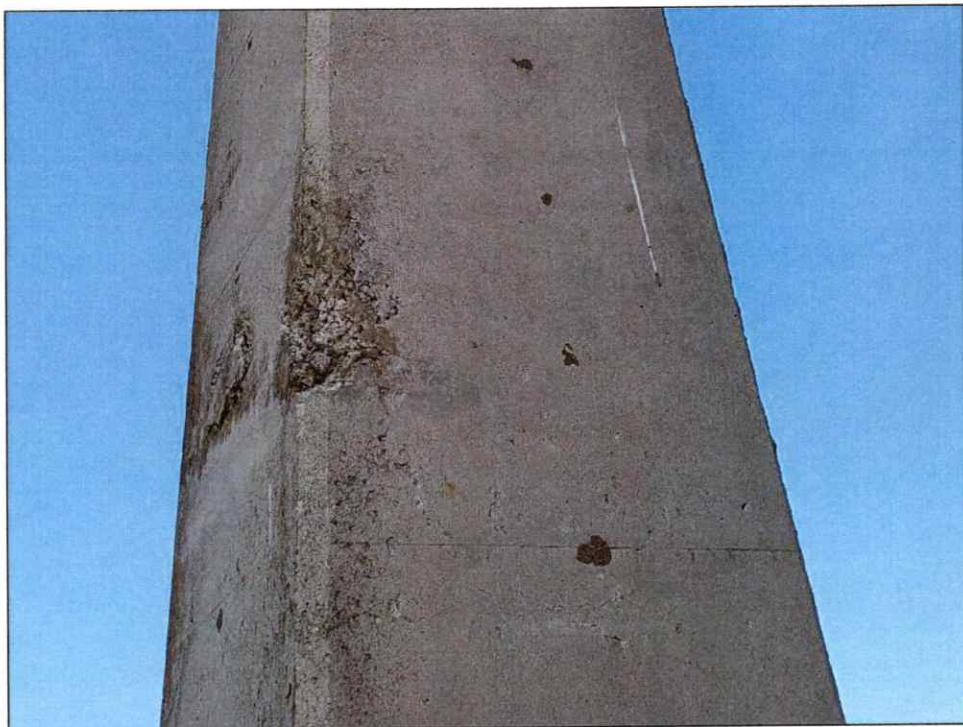
The pier legs, especially the north pier, were constructed with a lot of honeycomb areas. There are several cracks and one spall area on the west leg of the north pier. There is water staining on the pier cap from the superstructure, but cap and leg areas seem to be dry now. There does not seem to be much change or additional deterioration when compared with previous inspections.

Picture 14: Honeycombing on west column of the north pier (Bridge 3).

- Consider upgrading railing to deep beam railing with tubular backup.
- Patch spall and honeycomb areas on piers legs. Epoxy-Urethane sealing could also be done after repairing the pier legs.
- Continue to use an asphalt sealer at the pavement joints over the piers and at the abutments.
- Monitor the settlement behind the north abutment and then patch the pavement when the bump up to the bridge becomes significant. Observe the embankment and any erosion or movement on the slopes possibly causing change that is affecting the settlement of the pavement above.
- Remove vegetation from the spill-through slope and around the piers and abutments.
- Remove asphalt covering the drip strip at the railing posts.

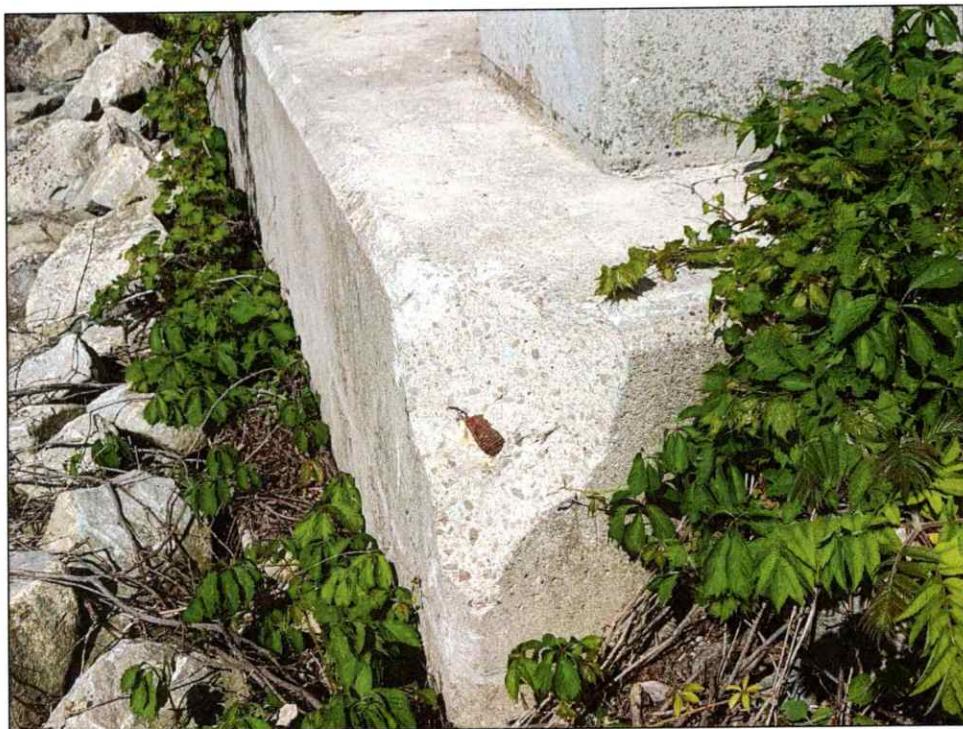
Picture 15: Spall with exposed rebar at southeast corner of the north pier (Bridge 3).

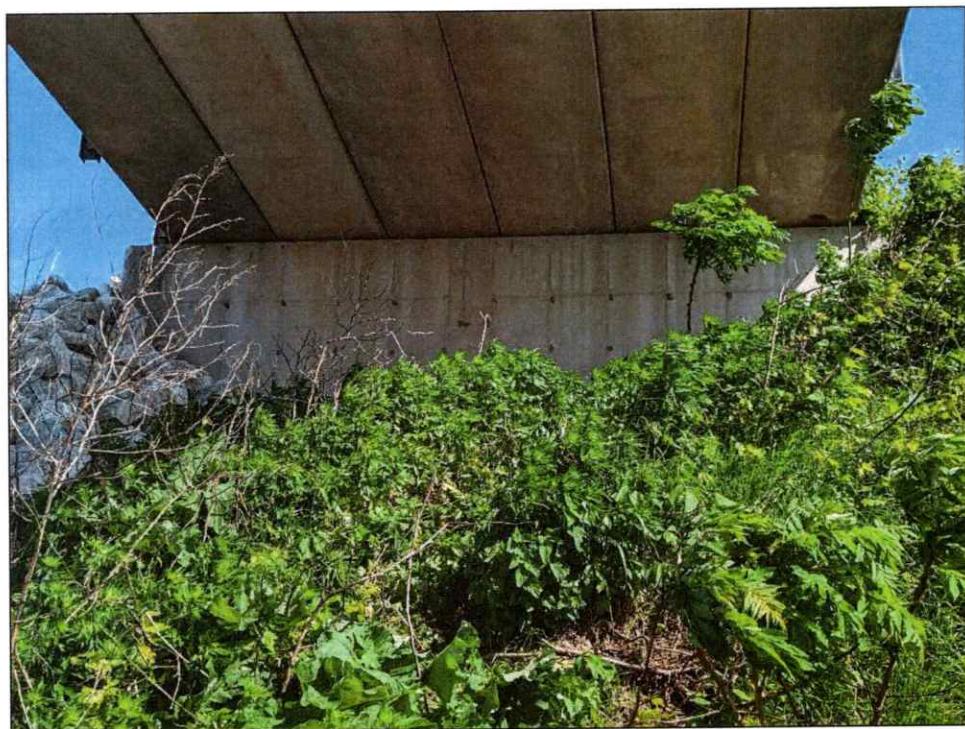
The abutments are in good condition. The water previously leaking from the superstructure has stained the face of the abutments (see Pictures 16 and 17), but the concrete surfaces all seem to be dry now. The spill-through slopes, in front of the abutments, are rutted, muddy with some rock protection. Vegetation on the spill-through slope can cause problems for the bridge (see Pictures 15 and 16). Growing trees can dislodge the rock from protecting the substructure, and the trees' growth can add unwanted forces to the bridge. Vines and other vegetation growing near or on the bridge holds moisture against the bridge and can possibly build up enough to affect normal performance of some aspects of the bridge.

Picture 16: North abutment (Bridge 3).

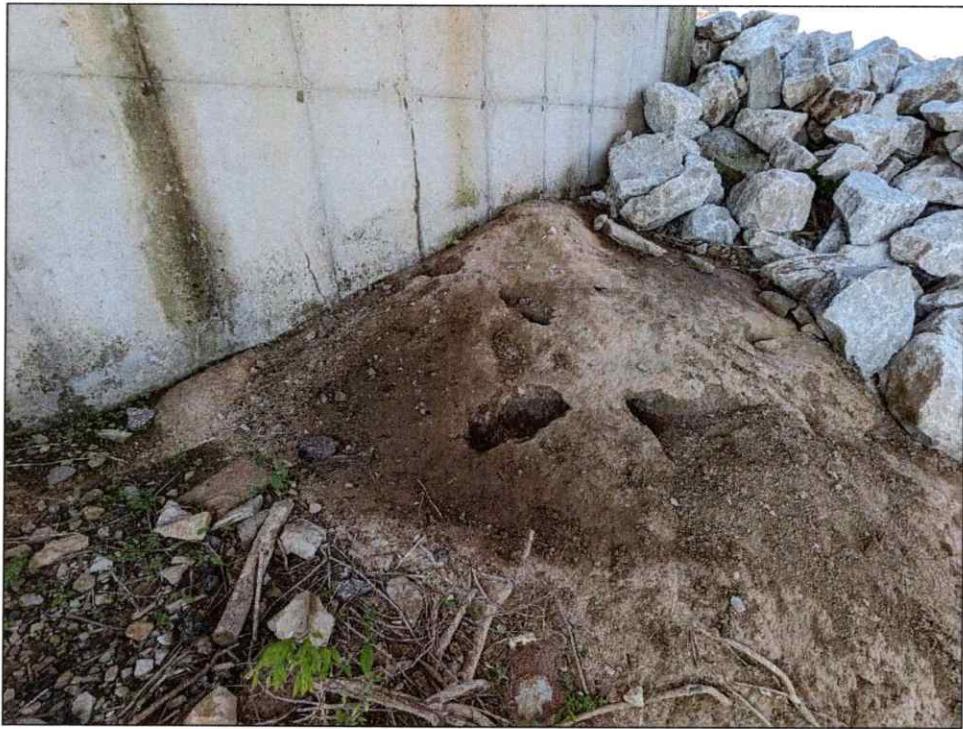
Picture 17: Animal holes at top of south slope (Bridge 3).

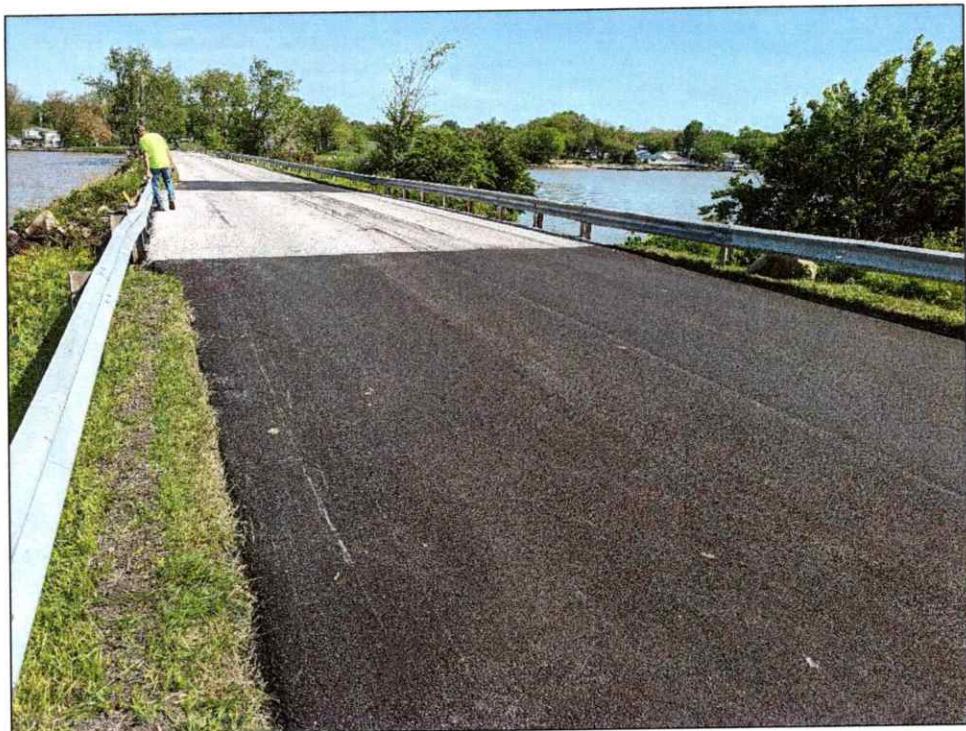
Picture 18: Looking north (Bridge 4).

The new approach pavement corrects settlement and smooths the road surface.

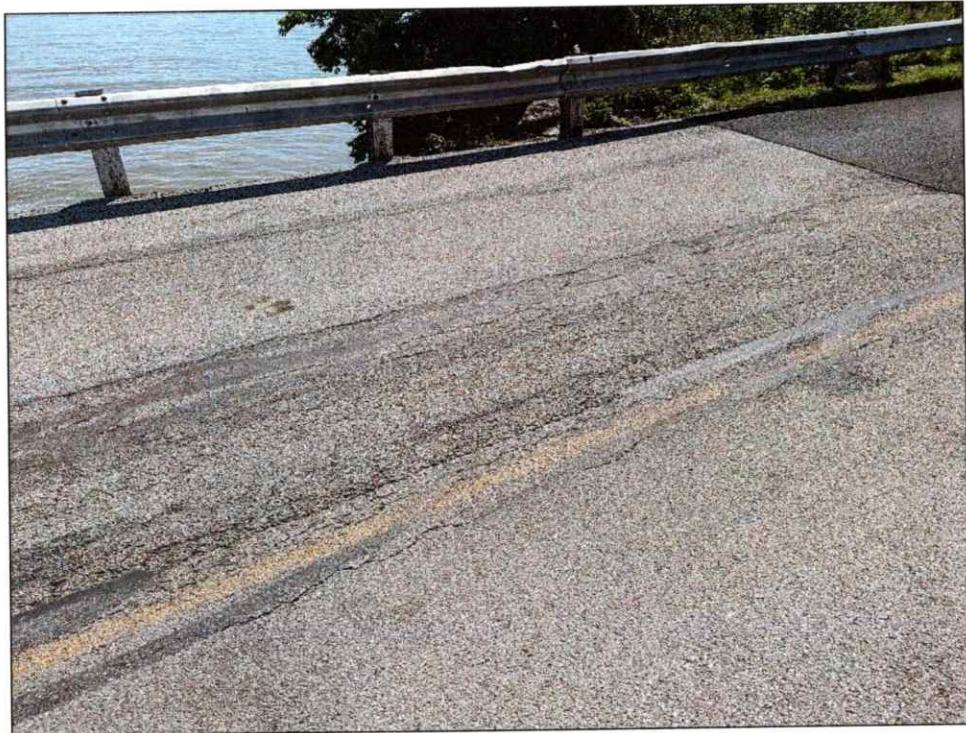
The key joints between the box beams were also repaired at the same time as Bridge 1. During this inspection, differential beam movement was not apparent even though large vehicles were crossing the bridge, but there were some reflective cracks from the box beam joints that had been sealed (or partly sealed). The beam joints on this bridge seem to be wider than normal and have always been a problem that is causing asphalt cracking (see Picture 19). The waterproofing membrane seems flexible enough to allow some movement between beams and still prevent leakage between the beams.

Picture 19: Wearing surface (Bridge 4).

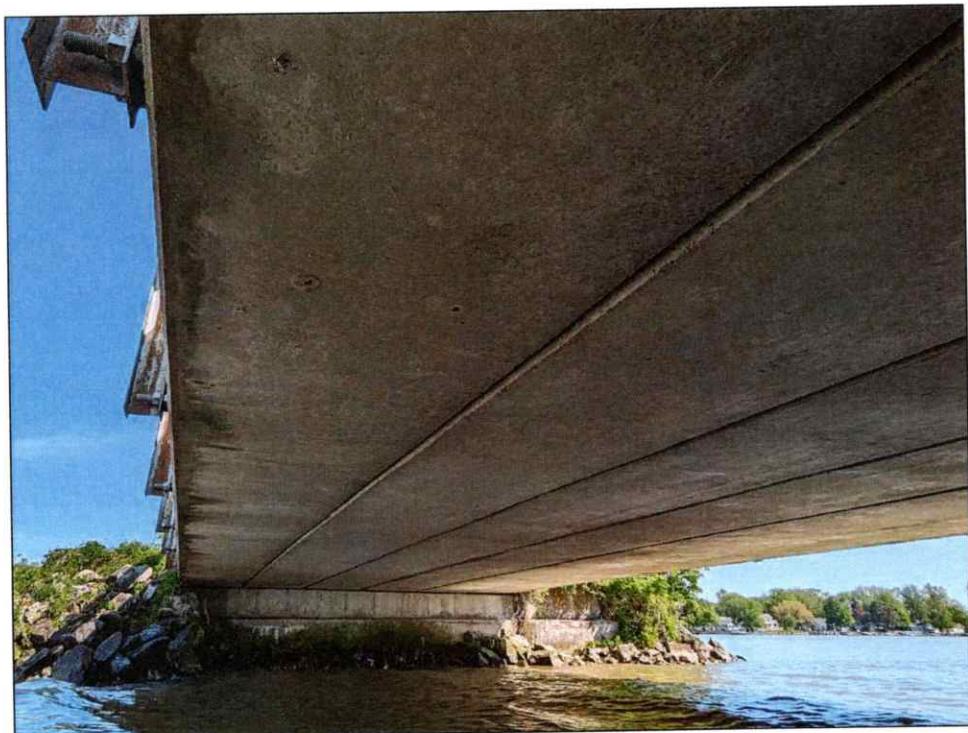
The box beams are in good condition, but have the key joint problem as mentioned above. There is no sign of leakage between the beams or water draining down the abutments, indicating that the waterproofing is working well.

Picture 20: Beams and north abutment (Bridge 4).

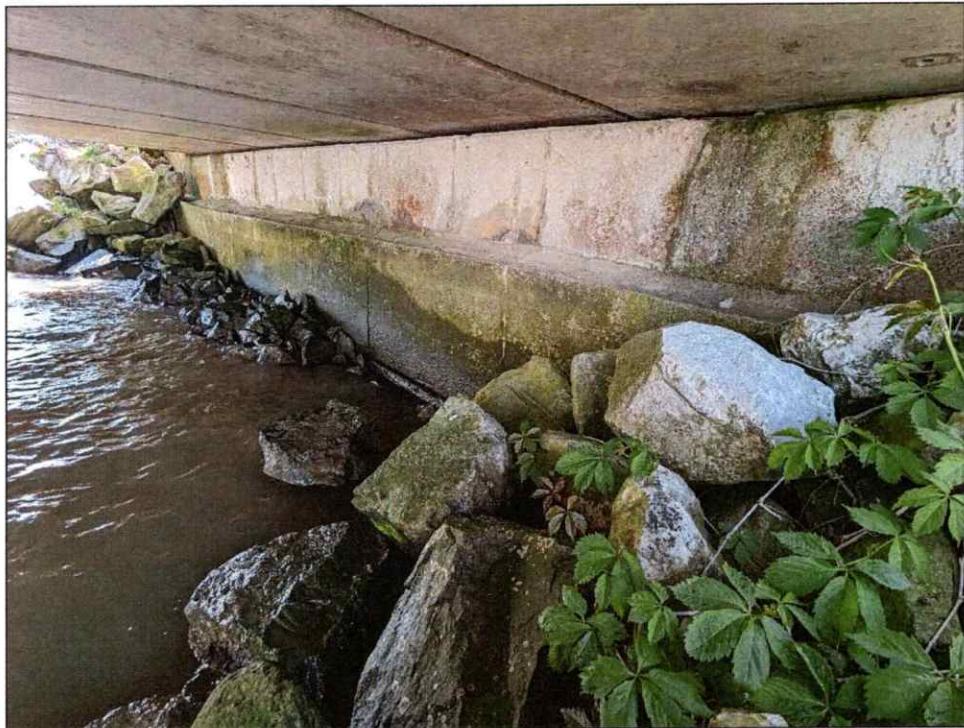
Picture 21: South abutment (Bridge 4).

The abutments are in good condition after being repaired since being severely eroded at the water level on the front faces. Rock channel protection was added around and in front of both abutments to protect against wave action, but there is some missing in front of the south abutment (see Picture 21).

- Consider upgrading railing to deep beam railing with tubular backup. At a minimum tighten the nuts on the posts as required.
- Maintain the rock channel protection around and in front of the abutments (especially at the south abutment).
- Continue to seal any reflective pavement cracking over the bridge.
- Remove asphalt covering the drip strip at the railing posts.

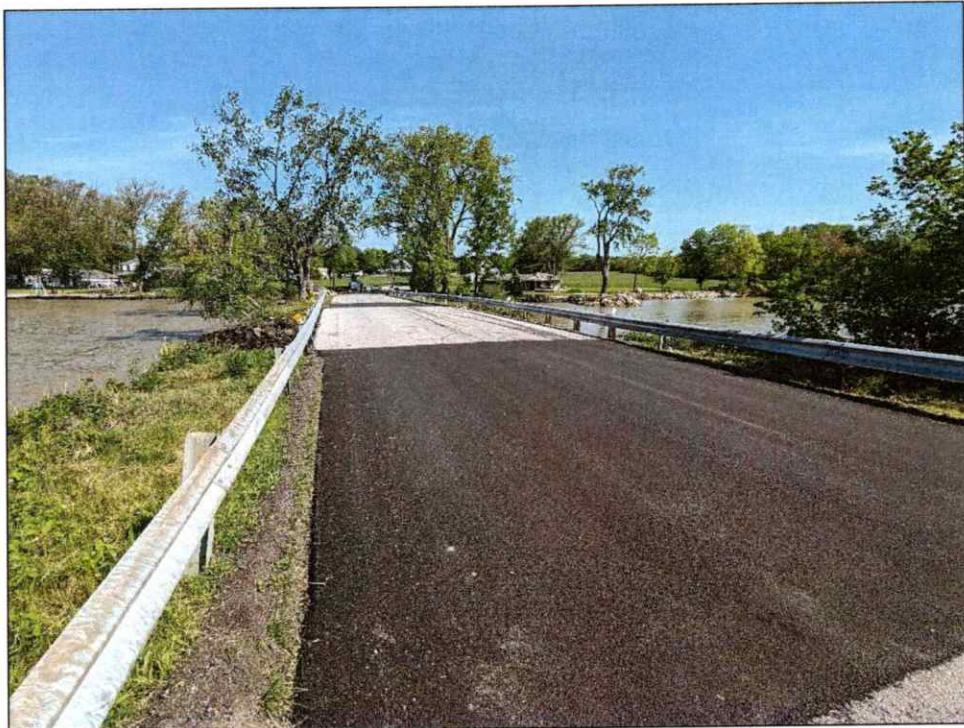
Picture 22: Looking north (Bridge 5).

The new approach pavement corrects settlement and smooths the road surface.

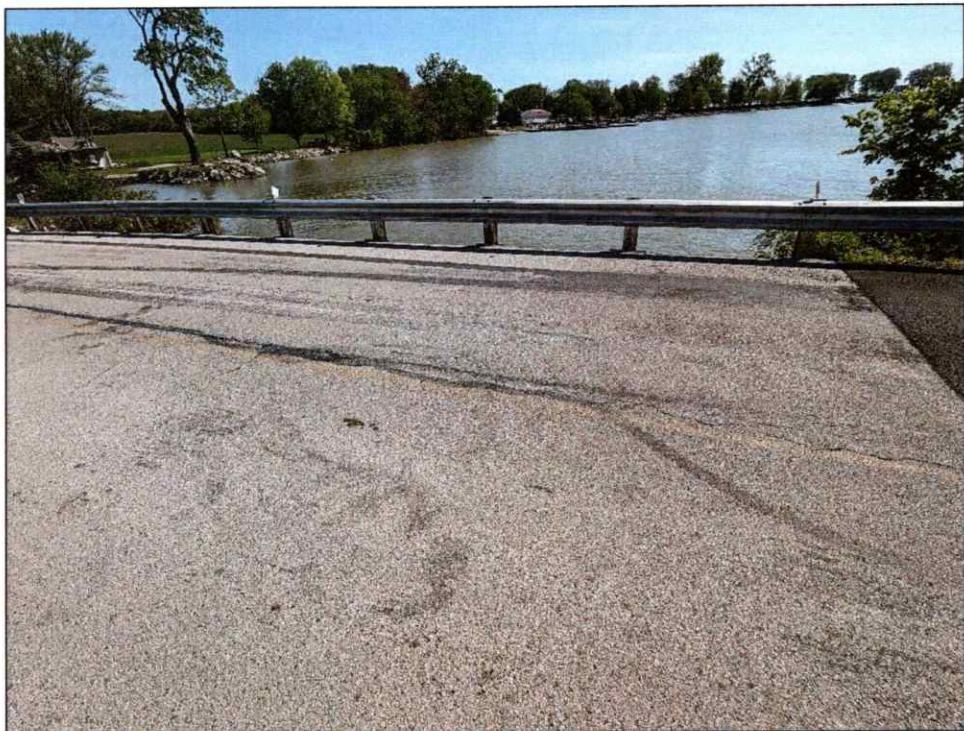
The key joints between the box beams were also repaired at the same time as Bridge 1. During this inspection, there was a longitudinal crack along the centerline that could be a reflective crack and may be indicative of differential movement from the box beam joint below.

Picture 23: Wearing surface (Bridge 5).

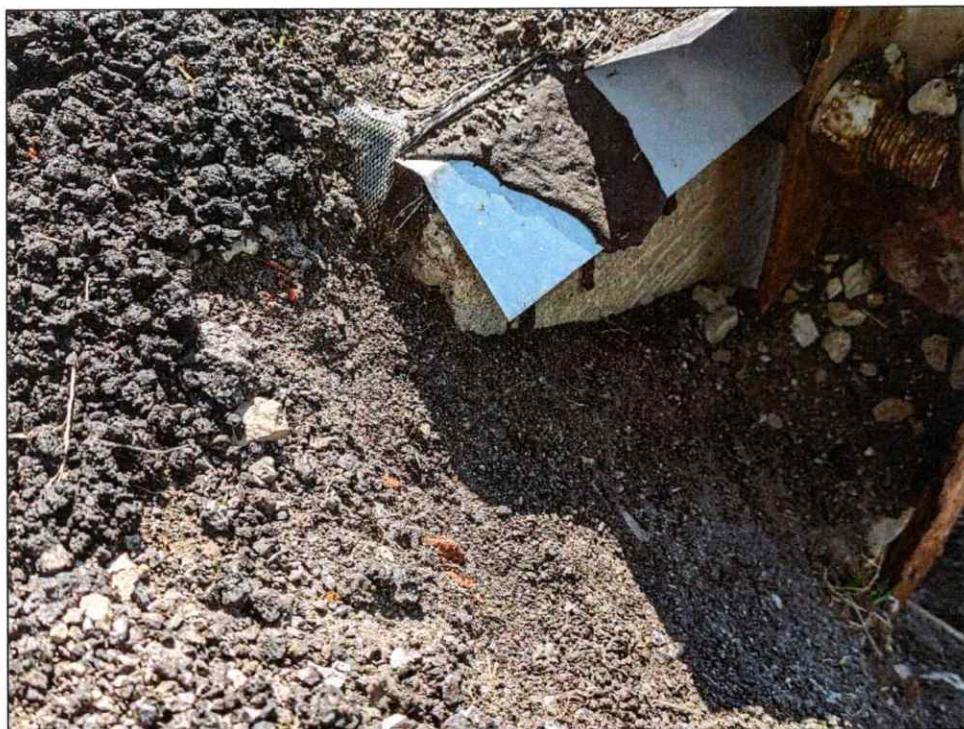
Picture 24: Erosion at northwest corner (Bridge 5).

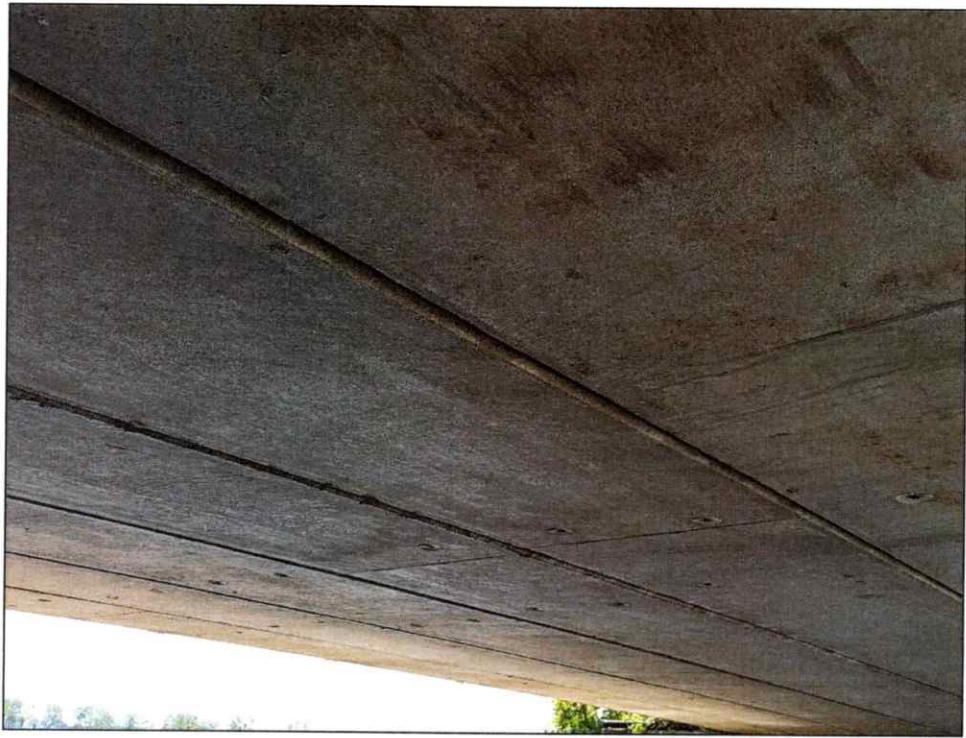
Picture 25: Beams (Bridge 5).

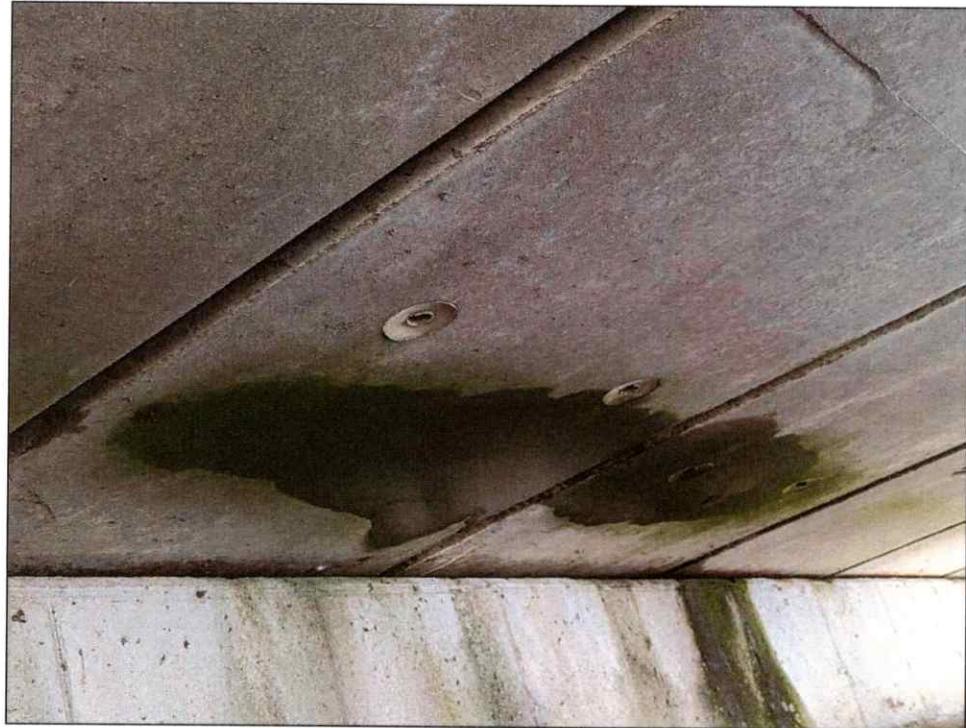
The box beams are in good condition. There is one active leak in the 2nd beam joint from the west at the north abutment indicating that the waterproofing is mostly working.

Picture 26: Leaking beam joint at north abutment (Bridge 5).
(This leak was not present during the previous inspection)

- Consider upgrading railing to deep beam railing with tubular backup.
- Maintain the rock channel protection around and in front of the abutments (especially at the south abutment).
- Seal the cracks in the asphalt wearing surface in hopes of eliminating or reducing the water leakage in the 2nd beam joint from the west. If the sealing does not work, then you may want to consider removing a portion of the asphalt over this section and repairing or overlaying the waterproofing.
- Remove asphalt covering the drip strip at the railing posts.

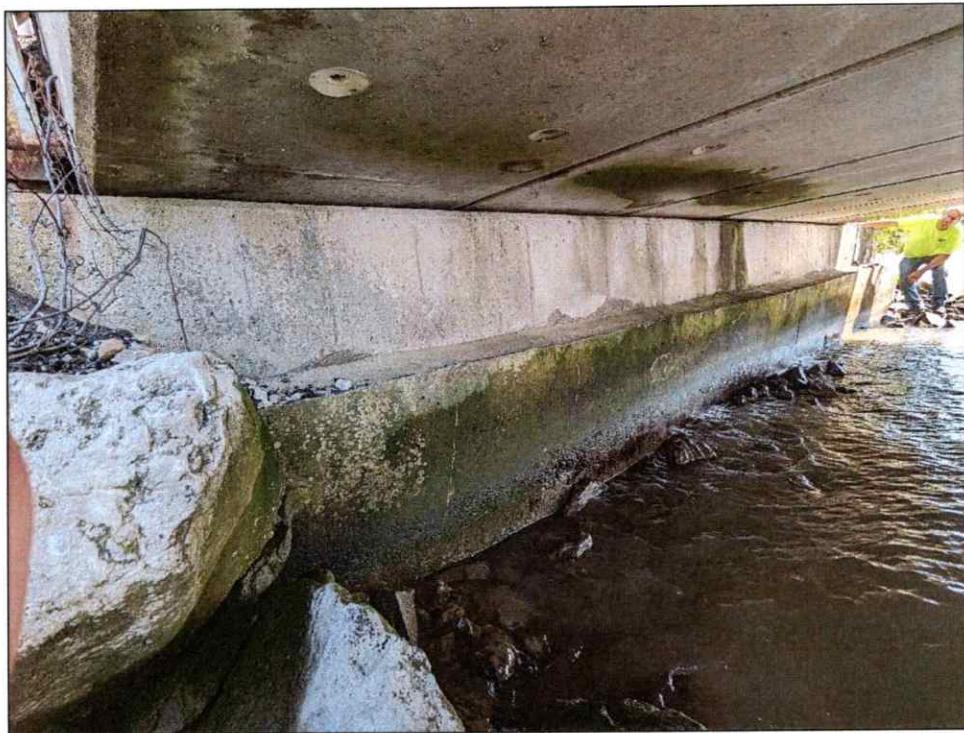
The abutments were repaired on this bridge also and are now in good condition. Rock channel protection was added around and in front of the abutments to protect against wave action but is now largely missing in front of both the north and south abutments (see Pictures 27 and 28).

Picture 27: North abutment (Bridge 5).

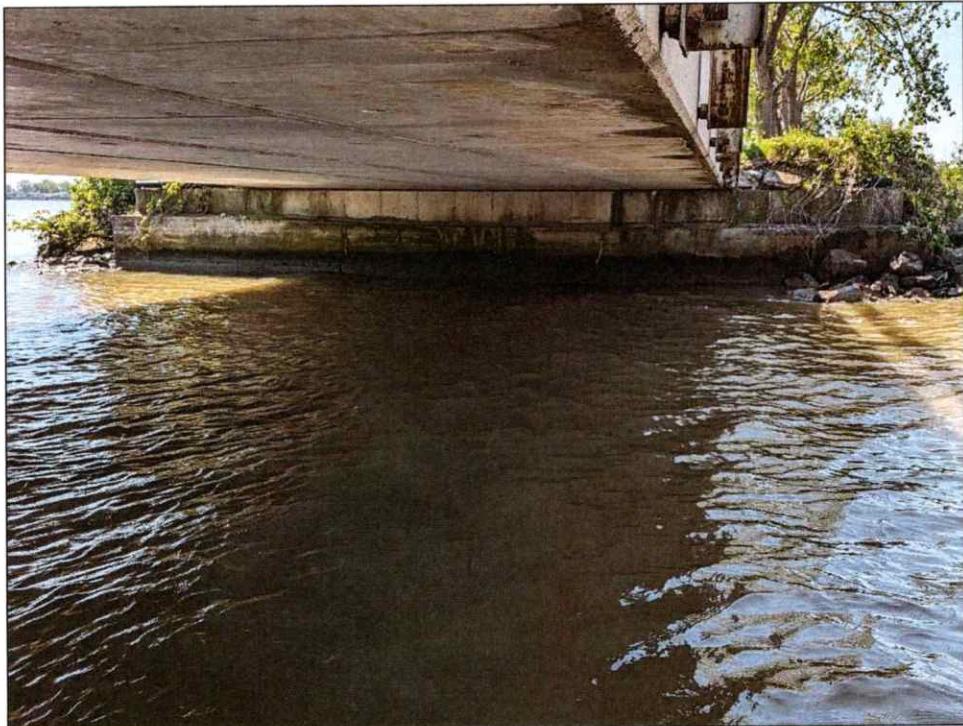
Picture 28: South abutment (Bridge 5).
