Re: 2024 Bridge Inspections
Johnson's Island Causeway
Ottawa, Ohio

On May 13, 2024, Richland Engineering Limited inspected the five bridge structures on the Johnson's Island Causeway Bridge. All five structures have precast prestressed box beam superstructures with asphalt wearing surfaces and reinforced concrete substructures.

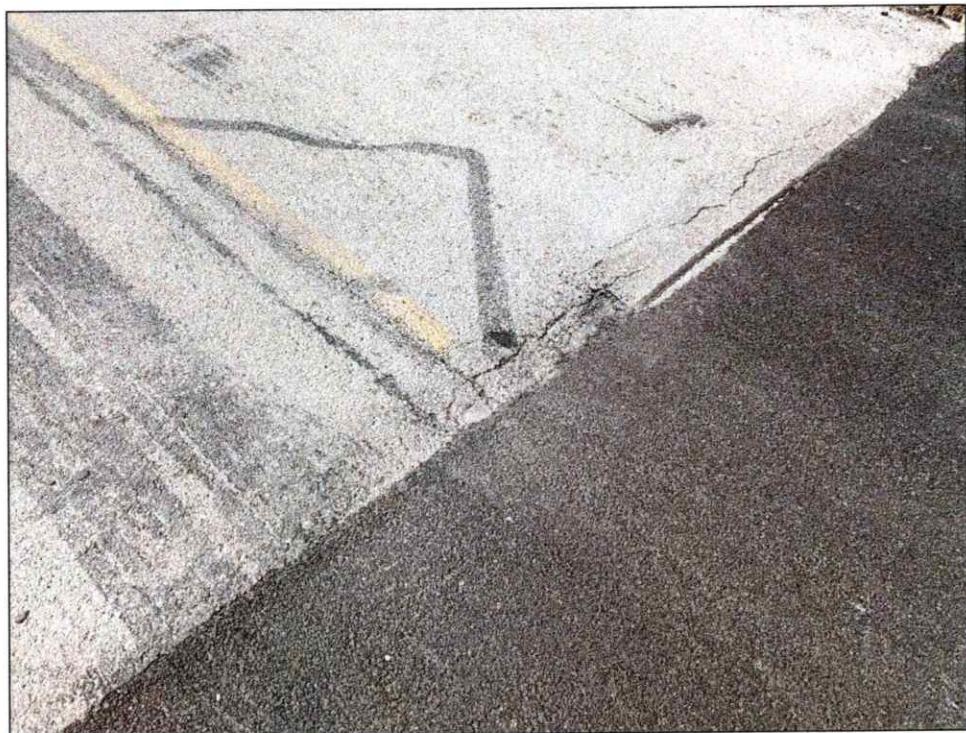
Picture 29: Transverse cracks at north transition (Bridge 5).

There are transverse cracks in the pavement at the north end of the bridge in the southbound lane. These cracks can be indicative of settlement behind the north abutment.
